**PERFLUORINATED COMPOUNDS PRELIMINARY ASSESSMENT  
SITE VISIT REPORT**

**WISCONSIN AIR NATIONAL GUARD  
TRUAX FIELD  
DANE COUNTY REGIONAL AIRPORT  
MADISON, WISCONSIN**

**December 2015**

**BB&E, Inc.**  
**December 2015**

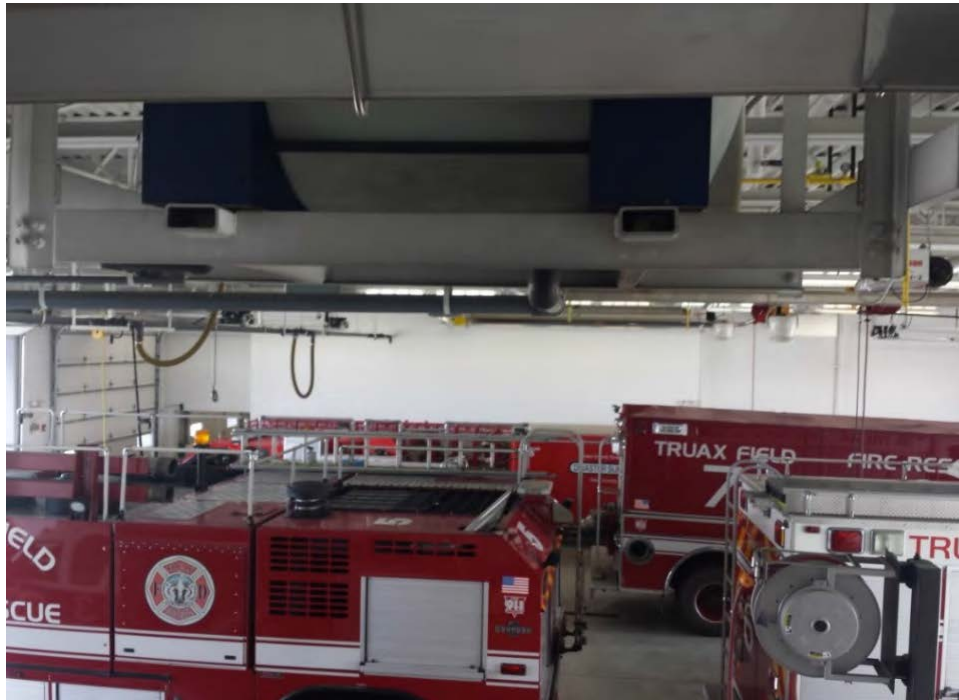
AFFF has been used by the WIANG FD for at least 20 years, and has been stored in Building 430 since it was built, circa 1995. Currently, there are approximately 471 gallons (gal) of AFFF carried in FD trucks and approximately 821 gal of AFFF serving as a backup supply, stored in the fire station. AFFF is transferred to vehicles within the fire station via overhead fill. Also, FD vehicles are washed within the fire station or the outside truck bays when necessary. There are trench drains located in the fire station and downgradient of the truck bays; therefore, any AFFF releases due to vehicle washing would be captured by the trench drains, which discharge into the sanitary sewer system.

Photo 1: Overhead foam fill at Fire Station (Building 430).

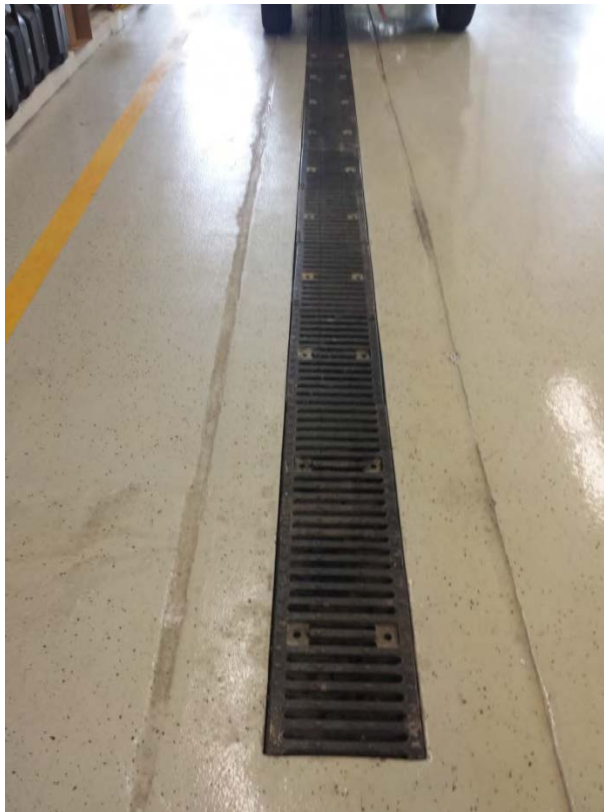
Photo 2: Trench drain (one of several) in the Fire Station (Building 430)

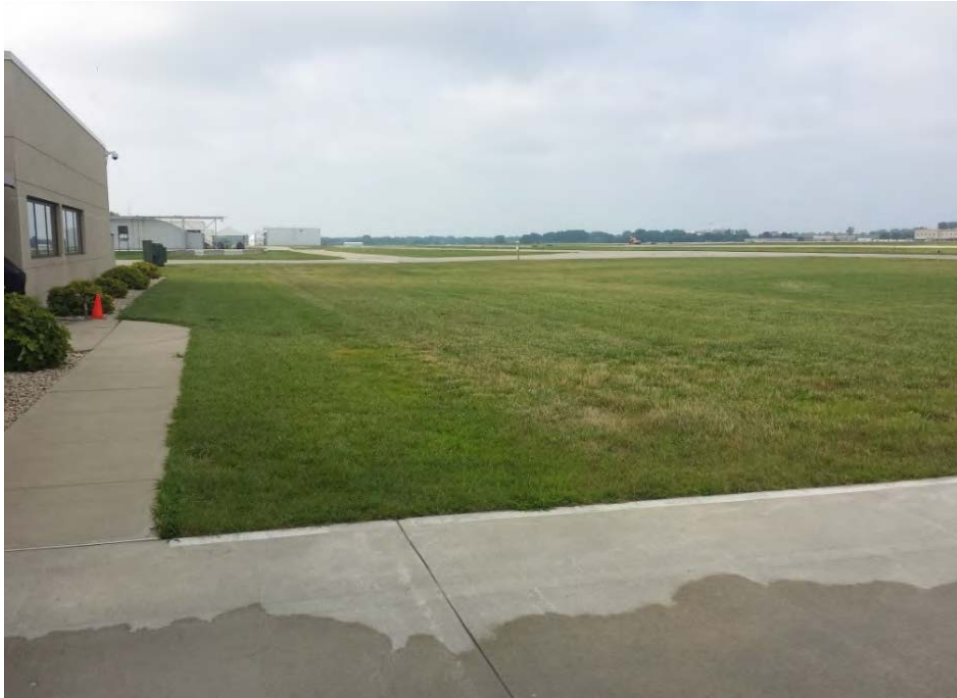
Photo 3: Looking south on west side of Fire Station (Building 430) where vehicle spray pattern tests are conducted.

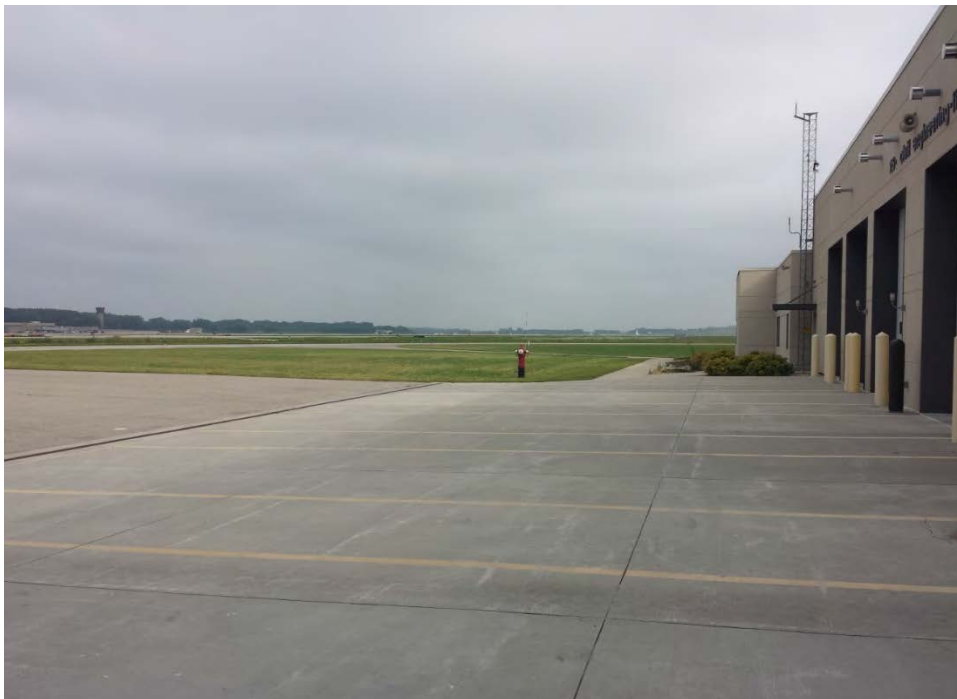
Photo 4: Looking north on west side of Fire Station (Building 430) where vehicle spray pattern tests are conducted.

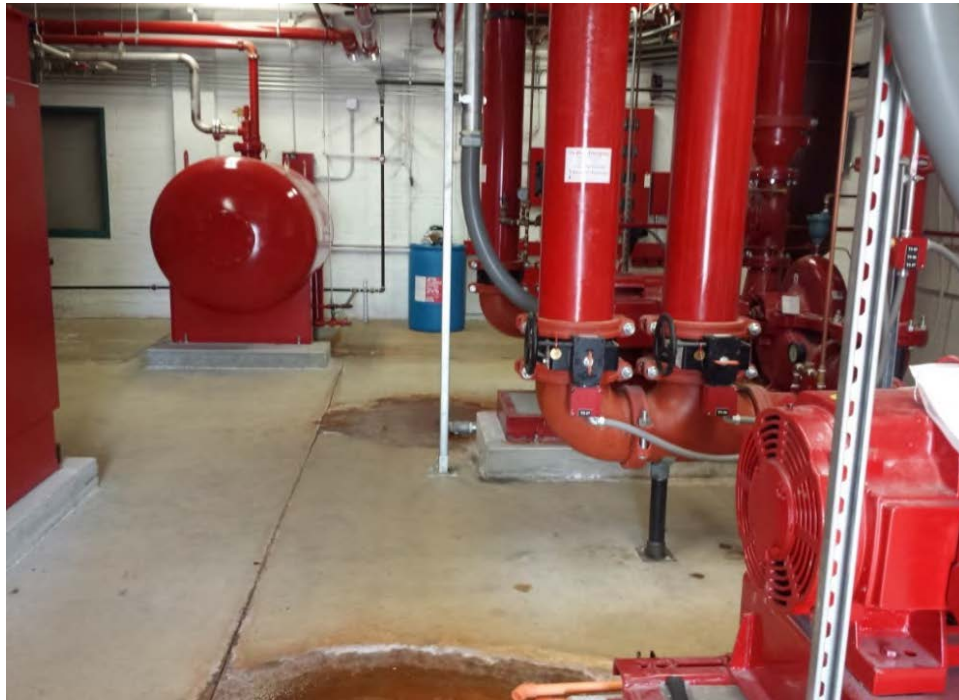
accidental release within the hangar would have been routed to the trench drains that historically led to an OWS which then discharged into the sanitary sewer system. The OWS was removed in 2009; no contamination was observed during removal (Leidos, 2015).

Photo 5: HEF storage (historically may have been AFFF storage) in the Mechanical Room of Hangar 400.

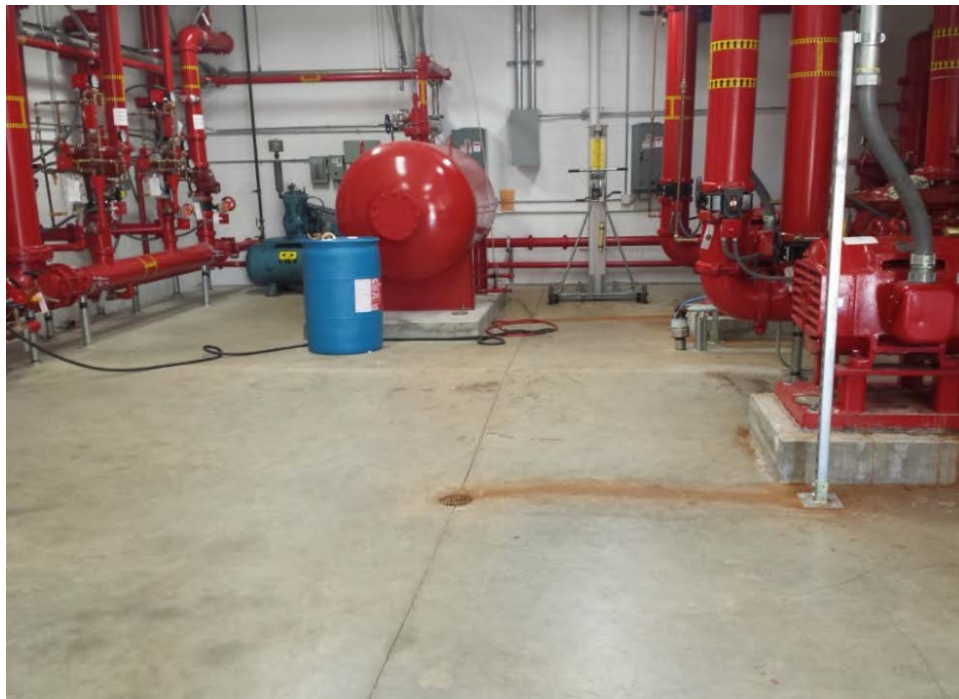
Photo 6: HEF storage (historically may have been AFFF storage) in the Mechanical Room of Hangar 406.

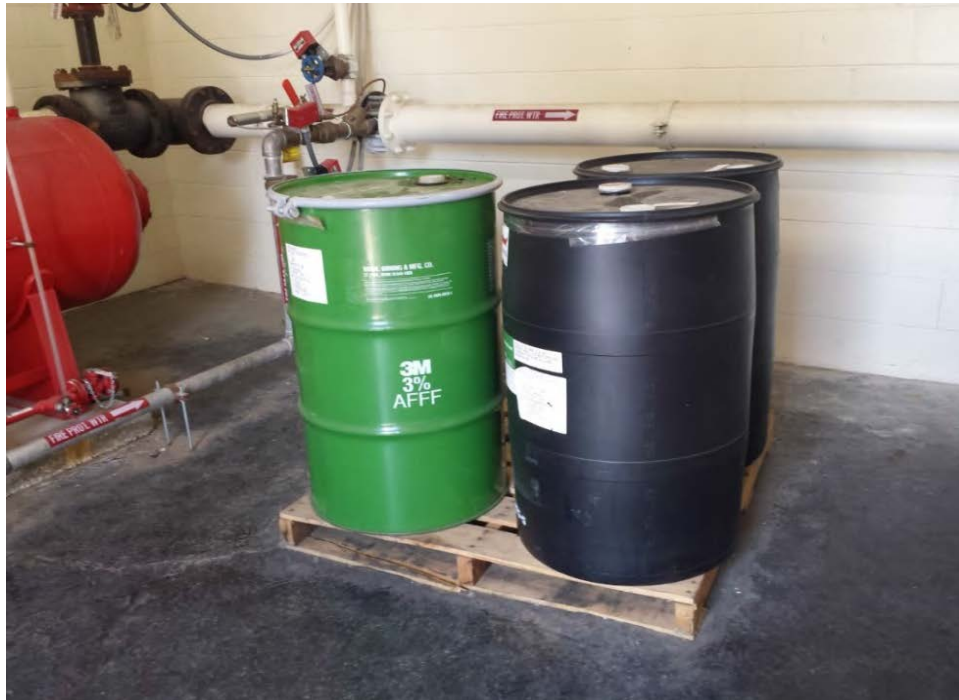
Photo 7: AFFF storage in the Mechanical Room of Hangar 414.

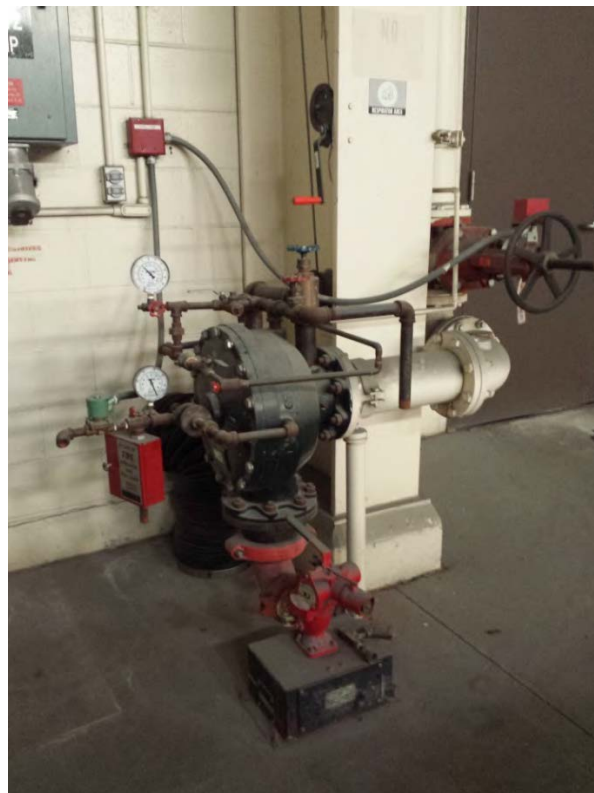
Photo 8: One of four fire suppression systems inside Hangar 414.

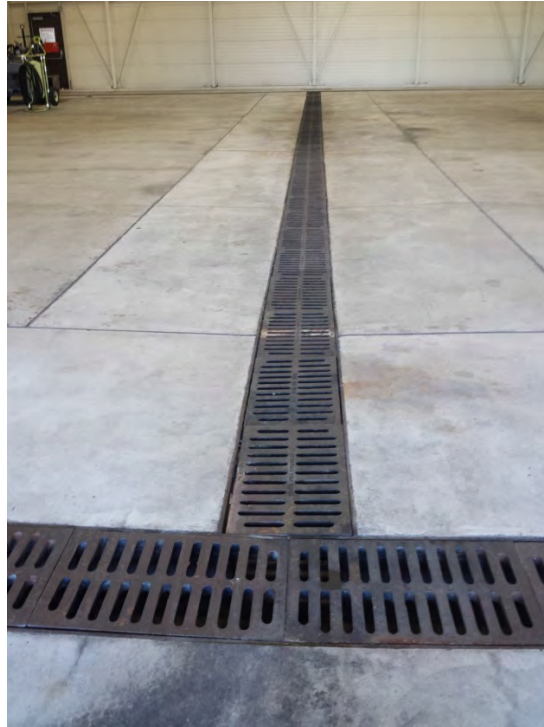
Photo 9: One of several trench drain inside Hangar 414.

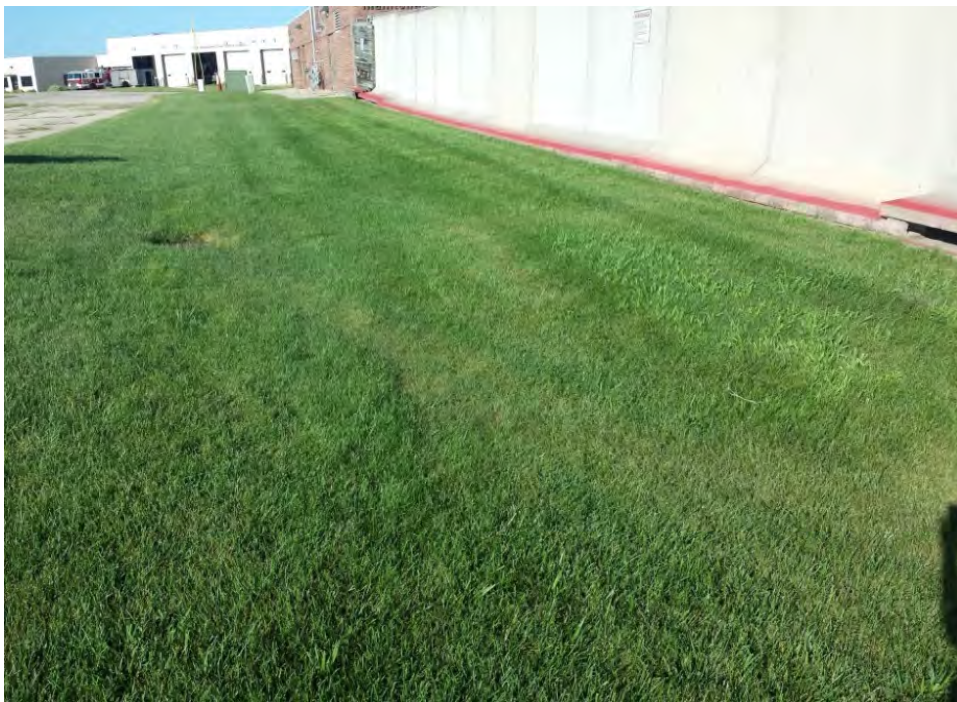
Photo 10: Drainage ditch between Buildings 414 and 431 – suspected area of 1981 fuel spill where foam was used.

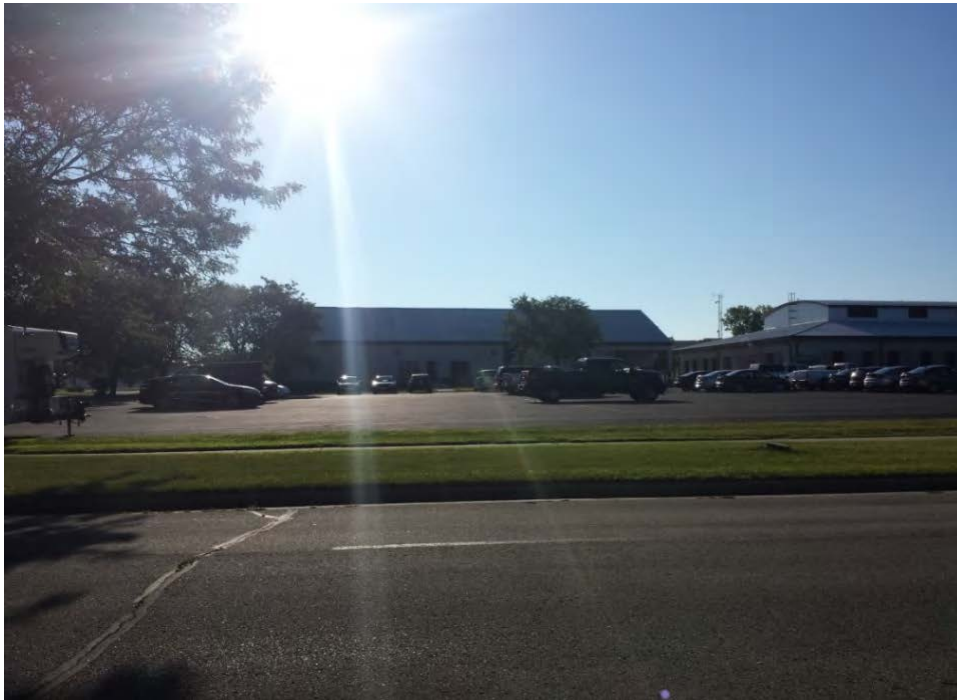
Photo 11: Looking east toward parking lot west of Building 503 where soil from 1981 fuel spill was placed on top of concrete pads and later disposed offsite.

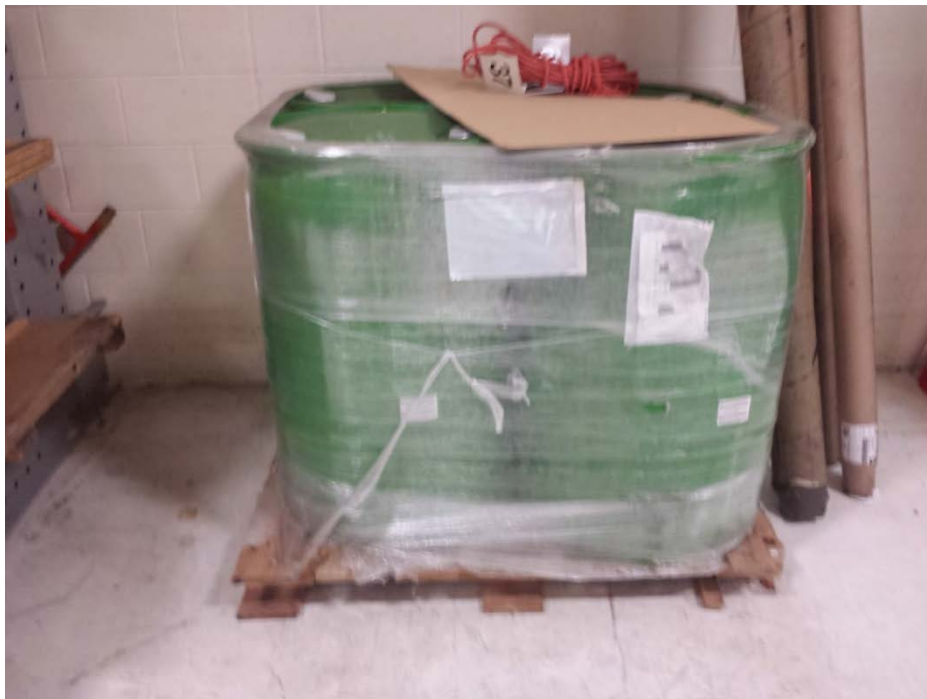
Four full drums of AFFF on a wooden pallet were observed during the PA site visit inside Building 510, which is where excess AFFF has been stored for an unknown amount of time. No secondary containment was provided for the drums; however, there were no visible floor drains or nearby mandors or overhead doors to facilitate an outside release of AFFF. There are no known records or personnel knowledge of accidental AFFF releases at Building 510.

Photo 12: AFFF storage in Building 510 (Supply).
