**WISCONSIN AIR NATIONAL GUARD  
HEADQUARTERS, 128th TACTICAL FIGHTER WING  
TRUAX FIELD  
MADISON, WISCONSIN**

**SITE ASSESSMENT REPORT**

**Site Assessment Report  
Wisconsin Air National Guard  
Headquarters, 128th Tactical Fighter Wing  
Truax Field  
Dane County Regional Airport  
Madison, Wisconsin**

**November 1991**

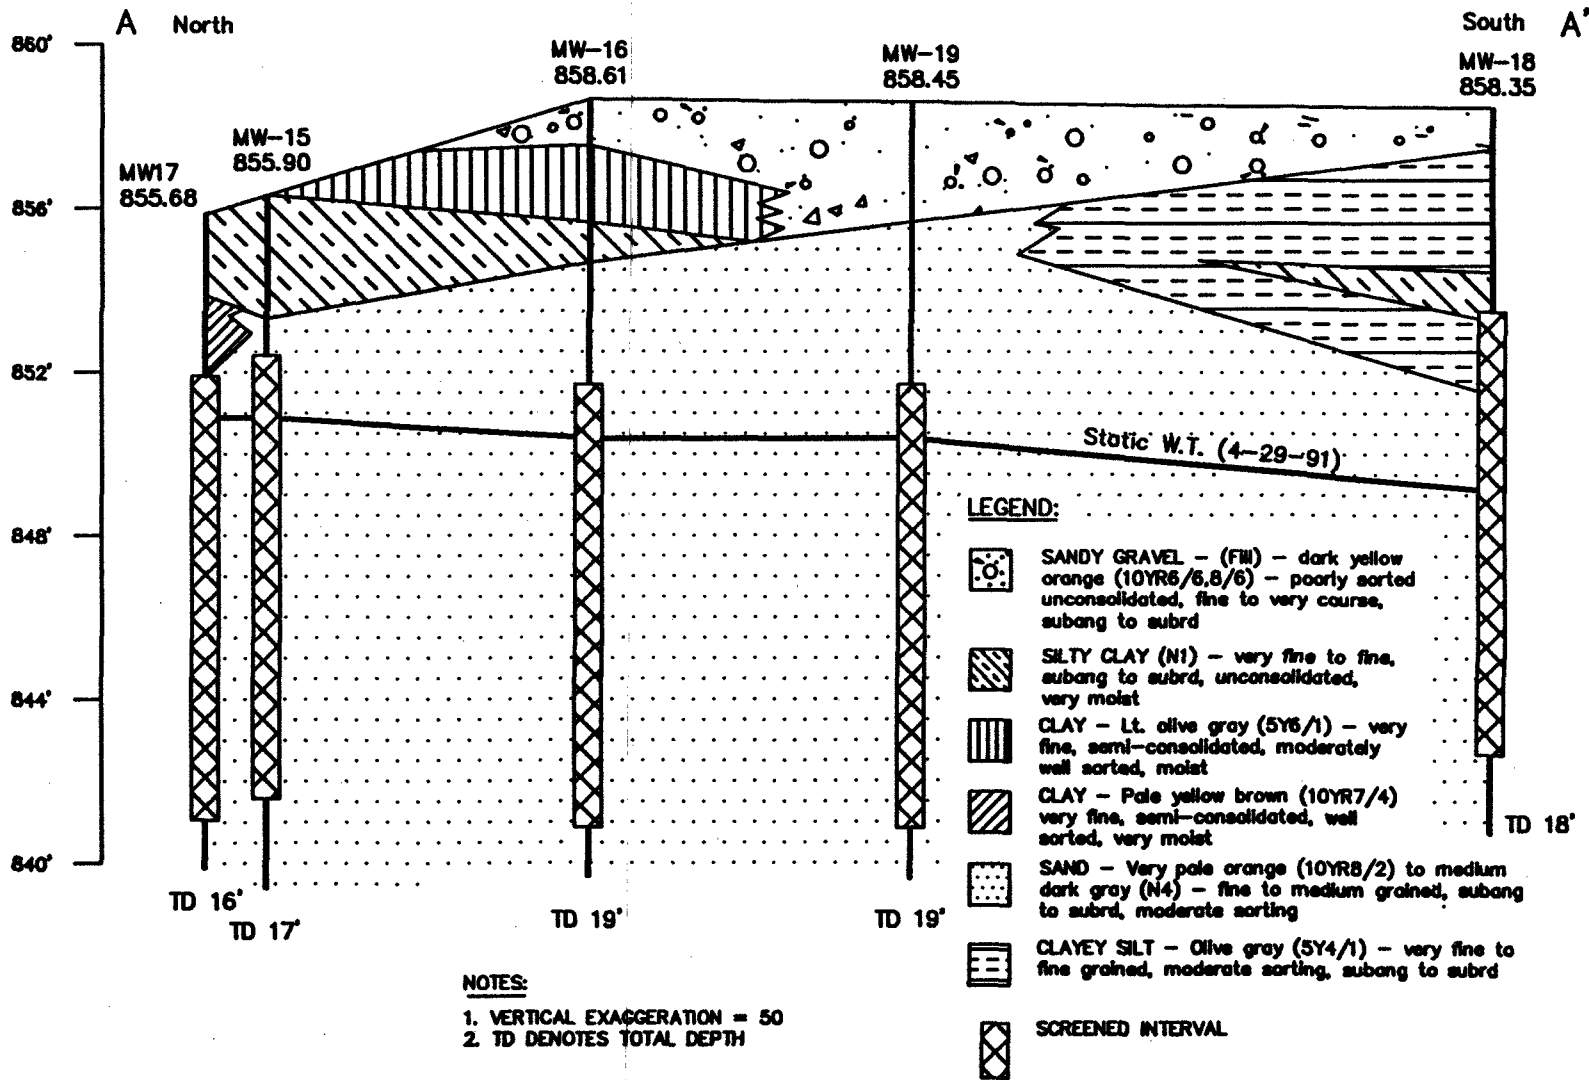
**Figure 7**  
**Generalized Geologic Cross-Section**

Truax Field is generally overlain by glacial outwash. A surficial layer of silty clay, approximately five feet in thickness, was encountered throughout the WANG facility. Below this clay layer, a fine- to medium-grained stratified sand was observed. Some gravelly sands were encountered with depth, but were discontinuous throughout the investigation area. In areas where construction activities have removed the surficial clays, replacement has been made with a sandy gravel fill material. Figure 7 is a generalized geological section through the WANG facility interpreted from Lithologic Logs (Appendix C) obtained during the current SA. Figure 8 illustrates the transect for the geological section.

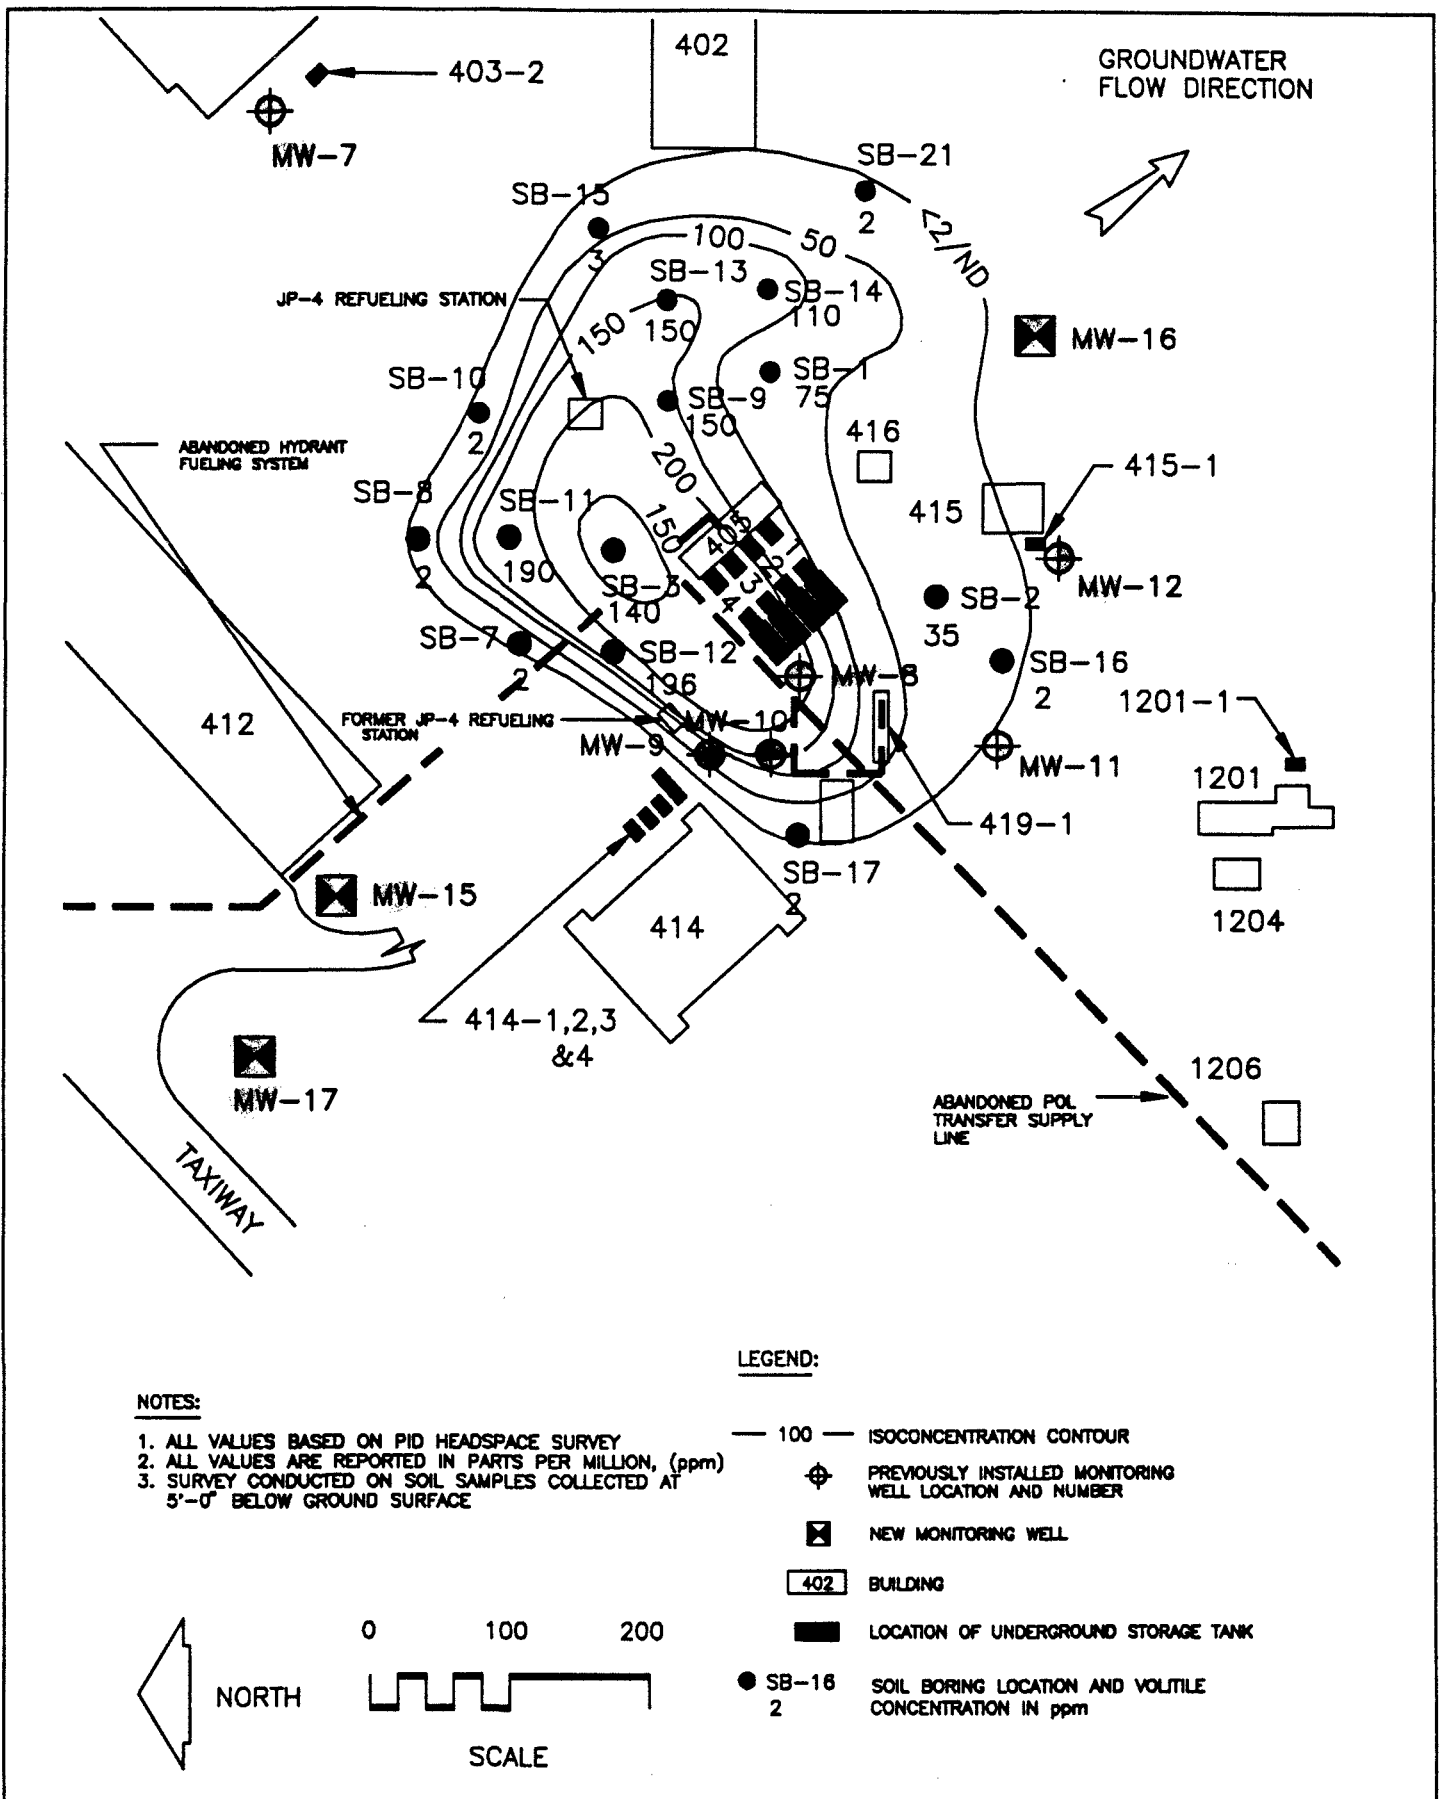
ADVANCED SCIENCES, INC.		FIGURE 11 TOTAL VOLATILE ISOCONCENTRATIONS MAP IN SOIL AT SITE 4	Wisconsin Air National Guard Headquarters, 128th Tactical Fighter Wing Truax Field Dane County Regional Airport Madison, Wisconsin
WANG17	NOVEMBER 1991

The initial round of groundwater sampling for the current investigation indicated benzene levels exceeding the ES of 5 ppb for monitoring wells MW-8, -9, -10, and -16. Benzene levels in these wells were 5,700 ppb, 28 ppb, 240 ppb and 38 ppb, respectively. Ethyl-benzene, at 520 ppb, exceeded the PAL of 272 ppb but is below the ES of 1360 ppb for monitoring well MW-8, while xylene exceeded the ES of 620 ppb for monitoring wells MW-8 and -10 at 3,900 ppb and 730 ppb, respectively (Table 7).

While sampling monitoring well MW-8, a non-measurable, green, oily film was observed. The WDNR representative, Carol McCurry, decided that the oily film did not constitute free product and analysis was not required. During the second sampling event, only the newly installed monitoring well MW-16 was sampled. No petroleum-based hydrocarbons were detected in MW-16 during this sampling event (Table 7). The extent of the petroleum-based hydrocarbons have been delineated for Site 4 from the data obtained during the current investigation (Tables 6 and 7).

It is also recommended that corrective actions be completed to remediate the soils and groundwater at Site 4.

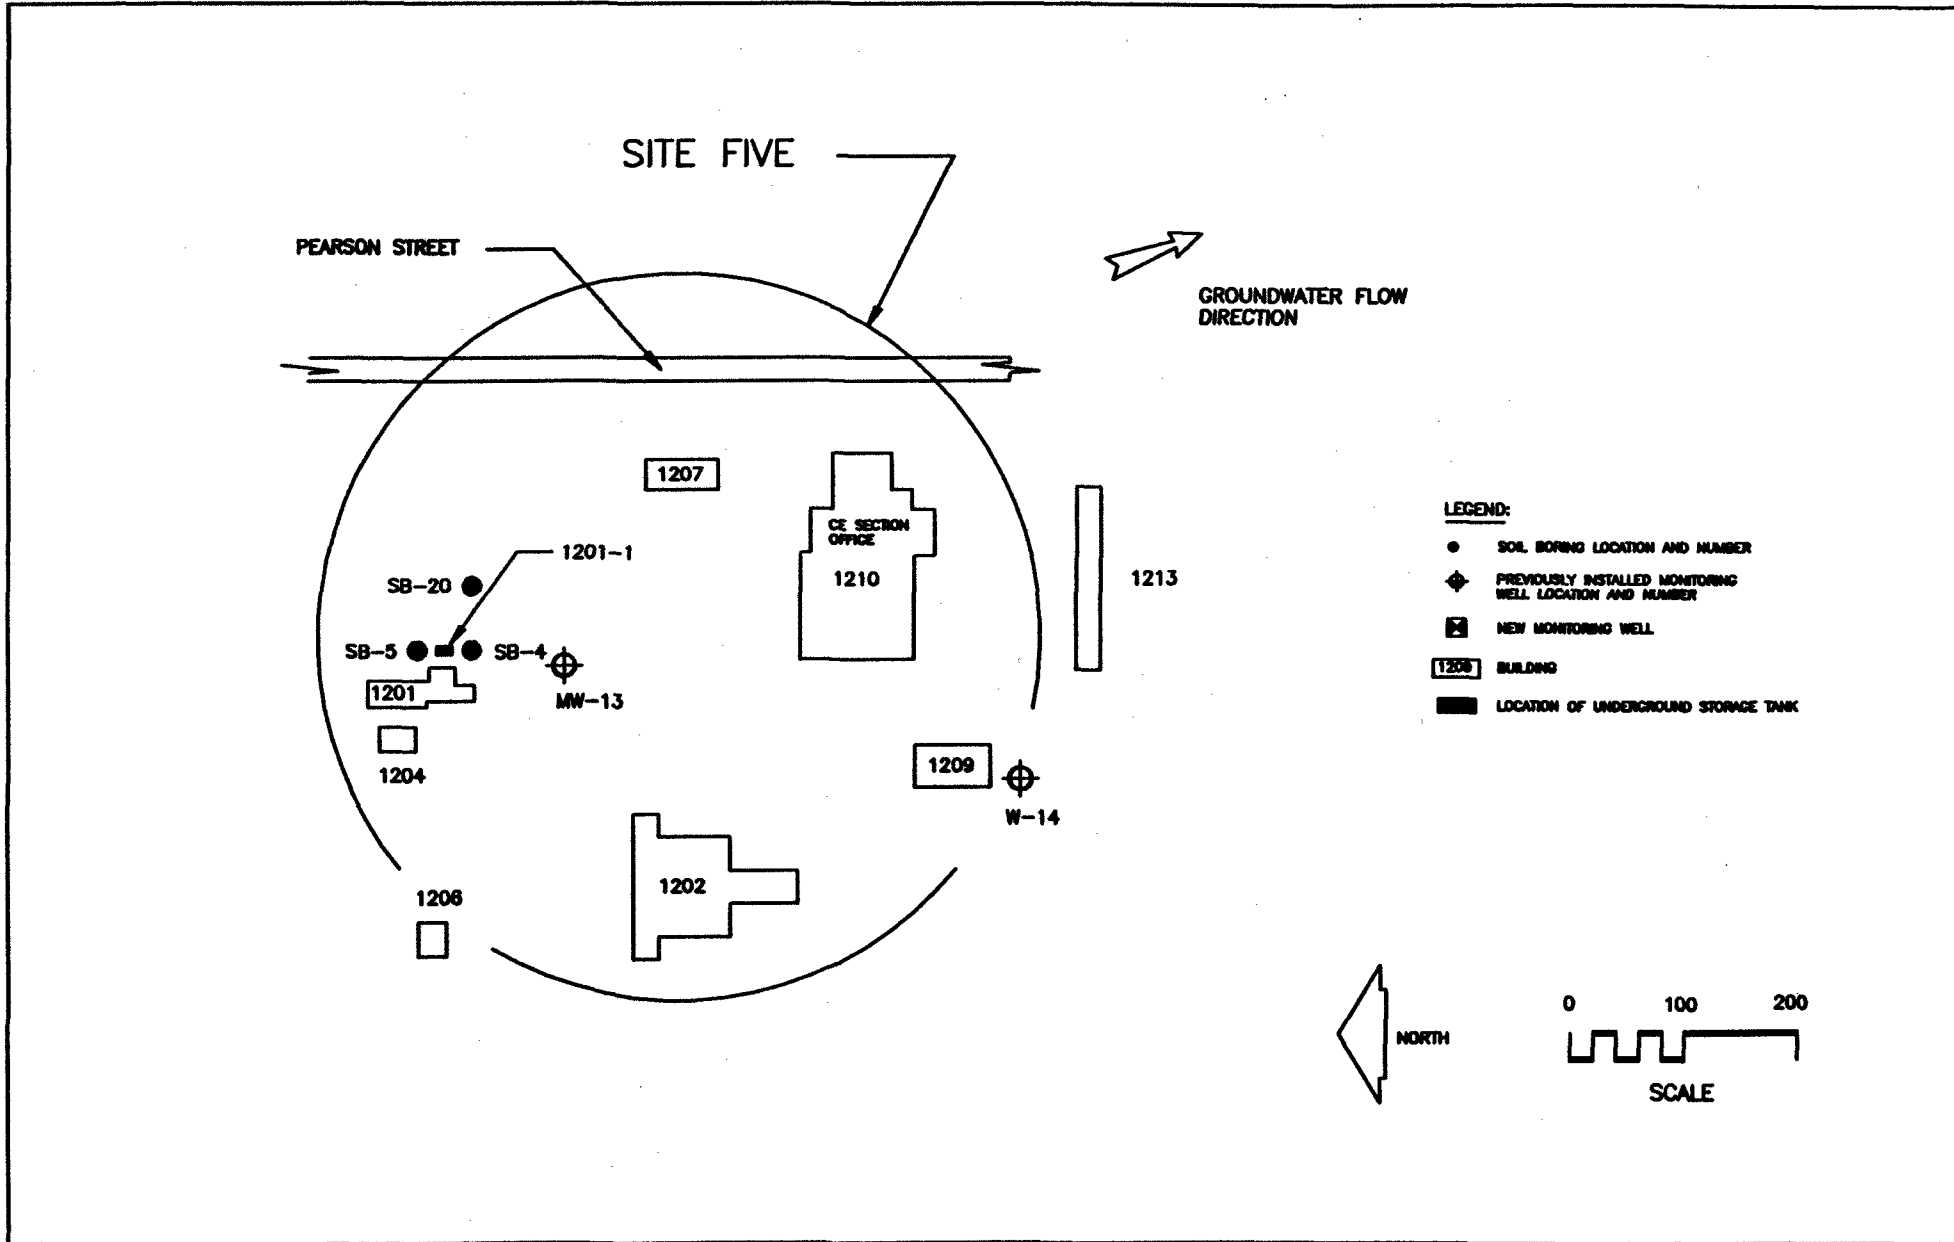
FIGURE 12. SITE 5 LOCATION MAP

Site 5 is located in the vicinity of Building 1201. Associated with Building 1201 is a 3000 gallon waste oil tank (1201-1) that failed the volumetric tightness test. A PA (Peer, 1988) was previously completed to investigate the historic JP-4 spill of approximately 100 gallons that occurred in August 1985 while disposing of used JP-4 into the waste oil tank. The PA reported that the spill had been adequately remediated. During the SI (Kapur, 1990) a monitoring well, MW-13, was completed approximately 70 feet west of the waste oil tank 1201-1 and identified the presence of chlorinated hydrocarbons in the groundwater. Analytical data from the SI (Kapur, 1990) identified trichloroethene (TCE) contamination at 2 ppb, ES is 1 ppb, in the groundwater (Table 5) and suggested that the UST was the probable source.

As indicated by the PID headspace survey (Appendix F) and laboratory confirmation analysis (Table 8) there is no contamination associated with Site 5 in the soils.

Monitoring wells MW-13 and -14 are the only wells associated with Site 5. These wells were installed and sampled during the previous SI (Kapur, 1990). Tetrachloroethene (PCE) at 2 ppb, which exceeds the ES of 1 ppb, was detected in monitoring well MW-13 during the previous SI (Table 5). However, the analytical analysis for MW-13 collected during the current investigation indicated ND levels of PCE (Table 9). Previous analytical results (Kapur, 1990) for monitoring well MW-14 did not indicate any contamination (Table 5). Monitoring well MW-14 was not sampled during the current investigation based on the previous SI analytical data (Kapur, 1990).

The waste oil tank 1201-1 is currently empty and is scheduled to be removed. The UST failed the tank volumetric tightness test but CE personnel informed ASI that the UST vent line had been damaged and could be the probable cause for the results of the tightness test. The current investigation indicated that the UST has not affected the surrounding soils and groundwater (Tables 8 and 9). Tank 1201-1 is abandoned and the WDNR requires that abandoned USTs must be permanently closed per WDNR requirements. Therefore, the UST, 1201-1, shall be removed according to WDNR requirements ILHR 10.732 and 10.734 as outlined in Section 6 of this document.

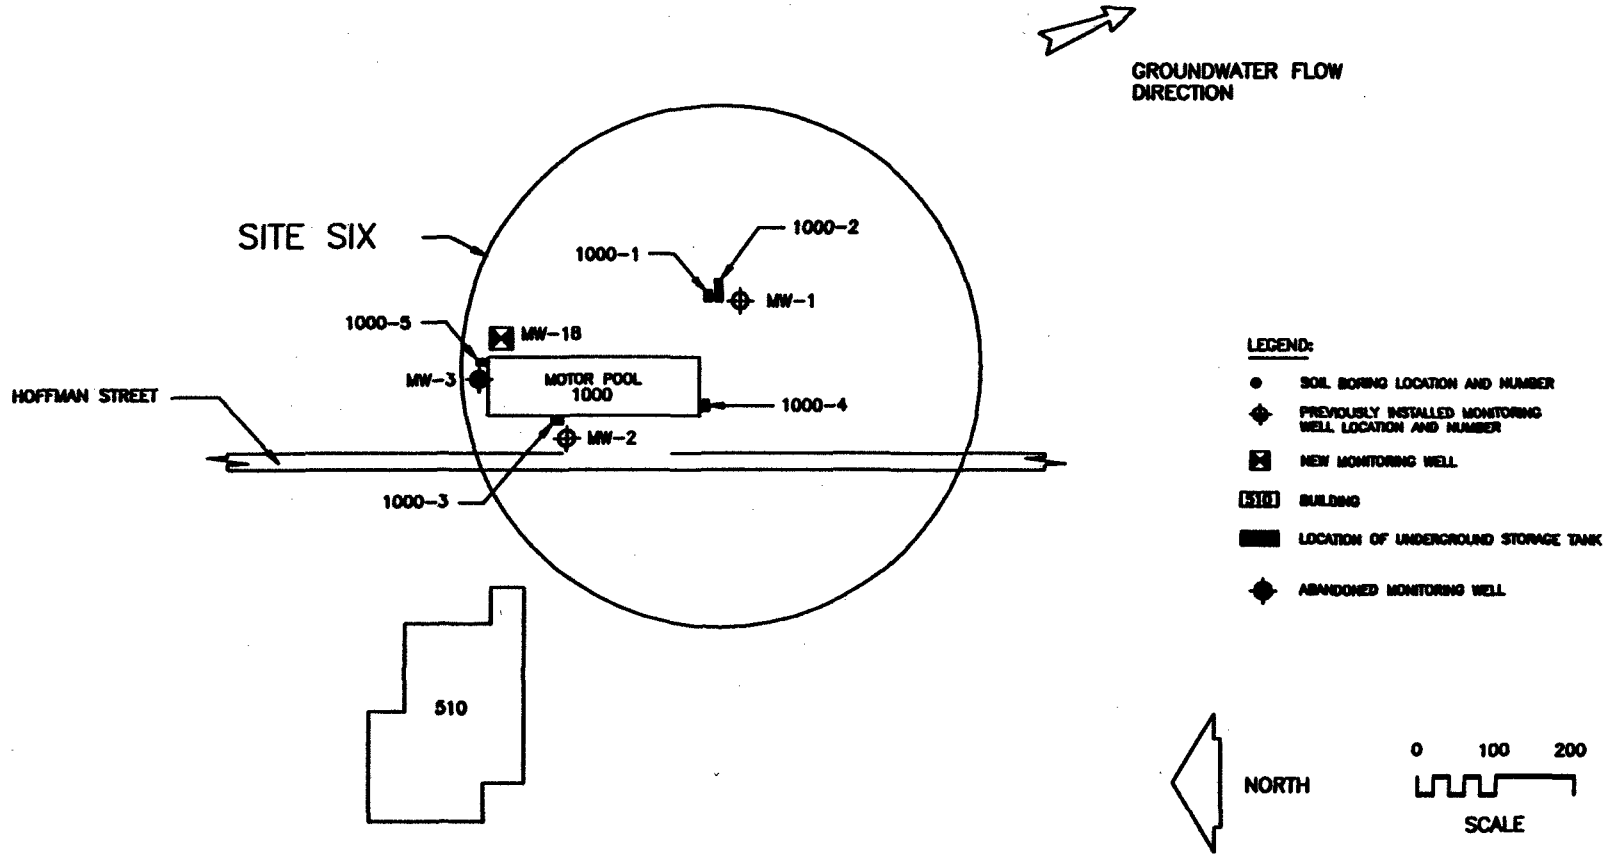
Site 6 includes monitoring wells MW-1, -2, -3 and -18 (Figure 13). Monitoring well MW-3 was found to be damaged and was abandoned per WDNR requirement ND 141.25. Monitoring well MW-18 was installed to replace MW-3. The soils surveyed with the PID during monitoring well MW-18 installation operations indicated the absence of volatile constituents in the soil (Appendix F). Analytical results for groundwater samples collected from the wells are tabulated in Table 10. Groundwater samples collected during the current investigation indicated levels of 1,2-

Monitoring well MW-2 was sampled during the previous and current investigation and was found to be free of any constituents of concern (Tables 5 and 10). Monitoring well MW-3 was sampled during the previous investigation and was found to be free of any constituents of concern (Table 5).

Associated with Site 6 are five USTs, 1000-1, -2, -3, -4, and -5 all of which successfully passed the volumetric tightness test. Two of the USTs, 1000-4, a 2000 gallon UST, and 1000-5, a 250 gallon UST, were removed sometime between May and September 1990 and contained fuel oil and waste oil, respectively. These tanks have not completed the permanent closure requirements in accordance with WDNR regulations. The USTs are not known to have leaked. Monitoring well MW-18 is located downgradient from the approximate former location of UST 1000-5. The soil and groundwater data from MW-18 indicates that there is no contamination associated with the former UST. The State of Wisconsin requires that all abandoned USTs be permanently closed per WDNR requirements. Therefore, the USTs 1000-4 and 1000-5 shall be closed according to WDNR requirements ILHR 10.732 and 10.734 as outlined in Section 6 of this document.

The remaining three USTs include a 12,000 gallon MOGAS UST, 1000-1; a 6,000 gallon diesel UST, 1000-2; and a 275 gallon oil/water separator, 1000-3 all of which are to be replaced pending fund approval. Monitoring well MW-1 is located downgradient of USTs 1000-1 and 1000-2. Groundwater data from this well indicate that the USTs have not leaked. Tank 1000-3 is an oil/water separator and no known leaks have been associated with this tank. The State of Wisconsin requires that USTs being removed from service be permanently closed per WDNR

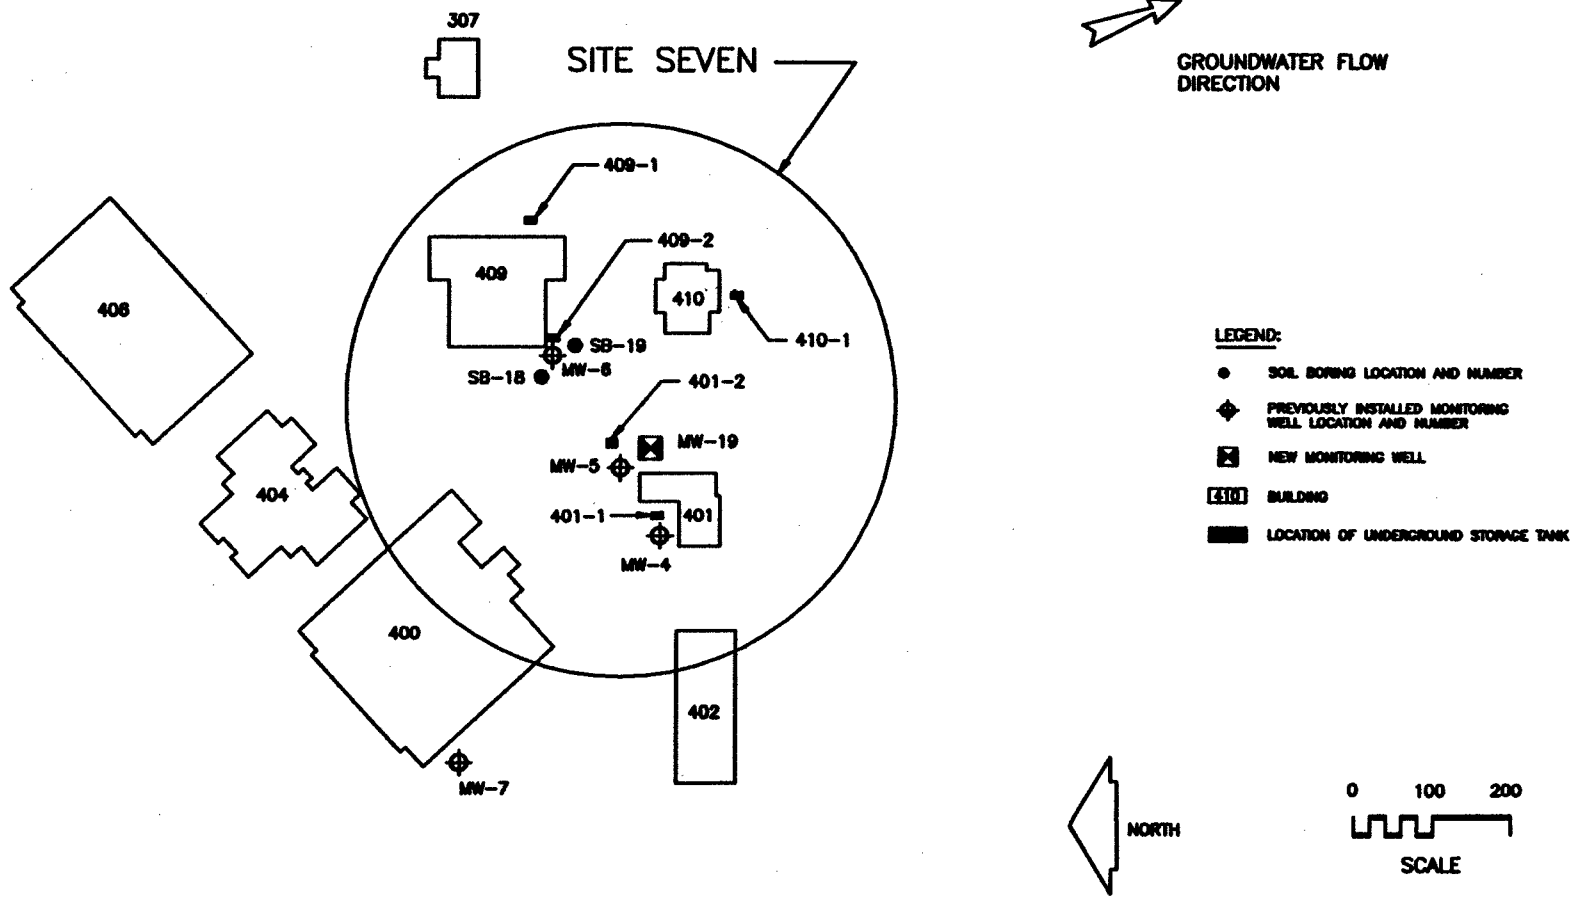
FIGURE 14. SITE 7 LOCATION MAP

As indicated from the PID headspace survey (Appendix F) and analytical analysis (Table 11) volatile constituents are absent in the soils at Site 7.

Site 7 includes monitoring wells MW-4, -5, -6, and -19. Monitoring wells MW-4, -5 and -6 were installed and sampled during the previous SI (Kapur, 1990). Elevated levels of TCE, exceeding the ES of 1 ppb, were detected in MW-4, -5 and -6 at 2.36 ppb, 11.8 ppb and 9.18 ppb, respectively (Table 5). Groundwater samples were collected during the current investigation from the monitoring wells and analyzed for volatile and semivolatile compounds. TCE exceeded the ES for monitoring wells MW-5 and -19 at 17 ppb and 11 ppb, respectively (Table 12).

Associated with Site 7 are five USTs which all have successfully passed the volumetric tightness test and are not known to have leaked. Two of the USTs, a 250 gallon oil/water separator (401-2), and a 2,000 gallon waste oil tank (409-1), have been removed. These USTs have not completed the state mandated permanent closure requirements per WDNR regulations. Therefore, the USTs shall be properly closed according to WDNR requirements ILHR 10.732 and 10.734 as outlined in Section 6 of this document.

A 275 gallon oil/water separator 409-2 is active and has been reported to be in good condition (Peer, 1988). The analytical results of monitoring well MW-6 and soil borings SB-18 and -19 in the vicinity of the oil/water separator 409-2 indicate that the surrounding soils and groundwater have not been impacted by this tank. The UST has not been associated with any leaks or spills and poses no immediate environmental concern.

The remaining UST, a 550 gallon waste oil tank (401-1), is to be replaced pending fund approval. No known leaks have been associated with this tank. The State of Wisconsin stipulates that USTs removed from service be permanently closed per WDNR requirements. Therefore, the UST shall be removed following WDNR closure requirements ILHR 10.732 as outlined in Section 6 of this document.
