Site Investigation Status Report and Remedial Action Plan

**Keller Property/Proposed Tennyson Ridge Development
Tennyson Lane/Whitman Lane
Madison, Dane County, Wisconsin**

October 13, 2016
Terracon Project No. 58167157

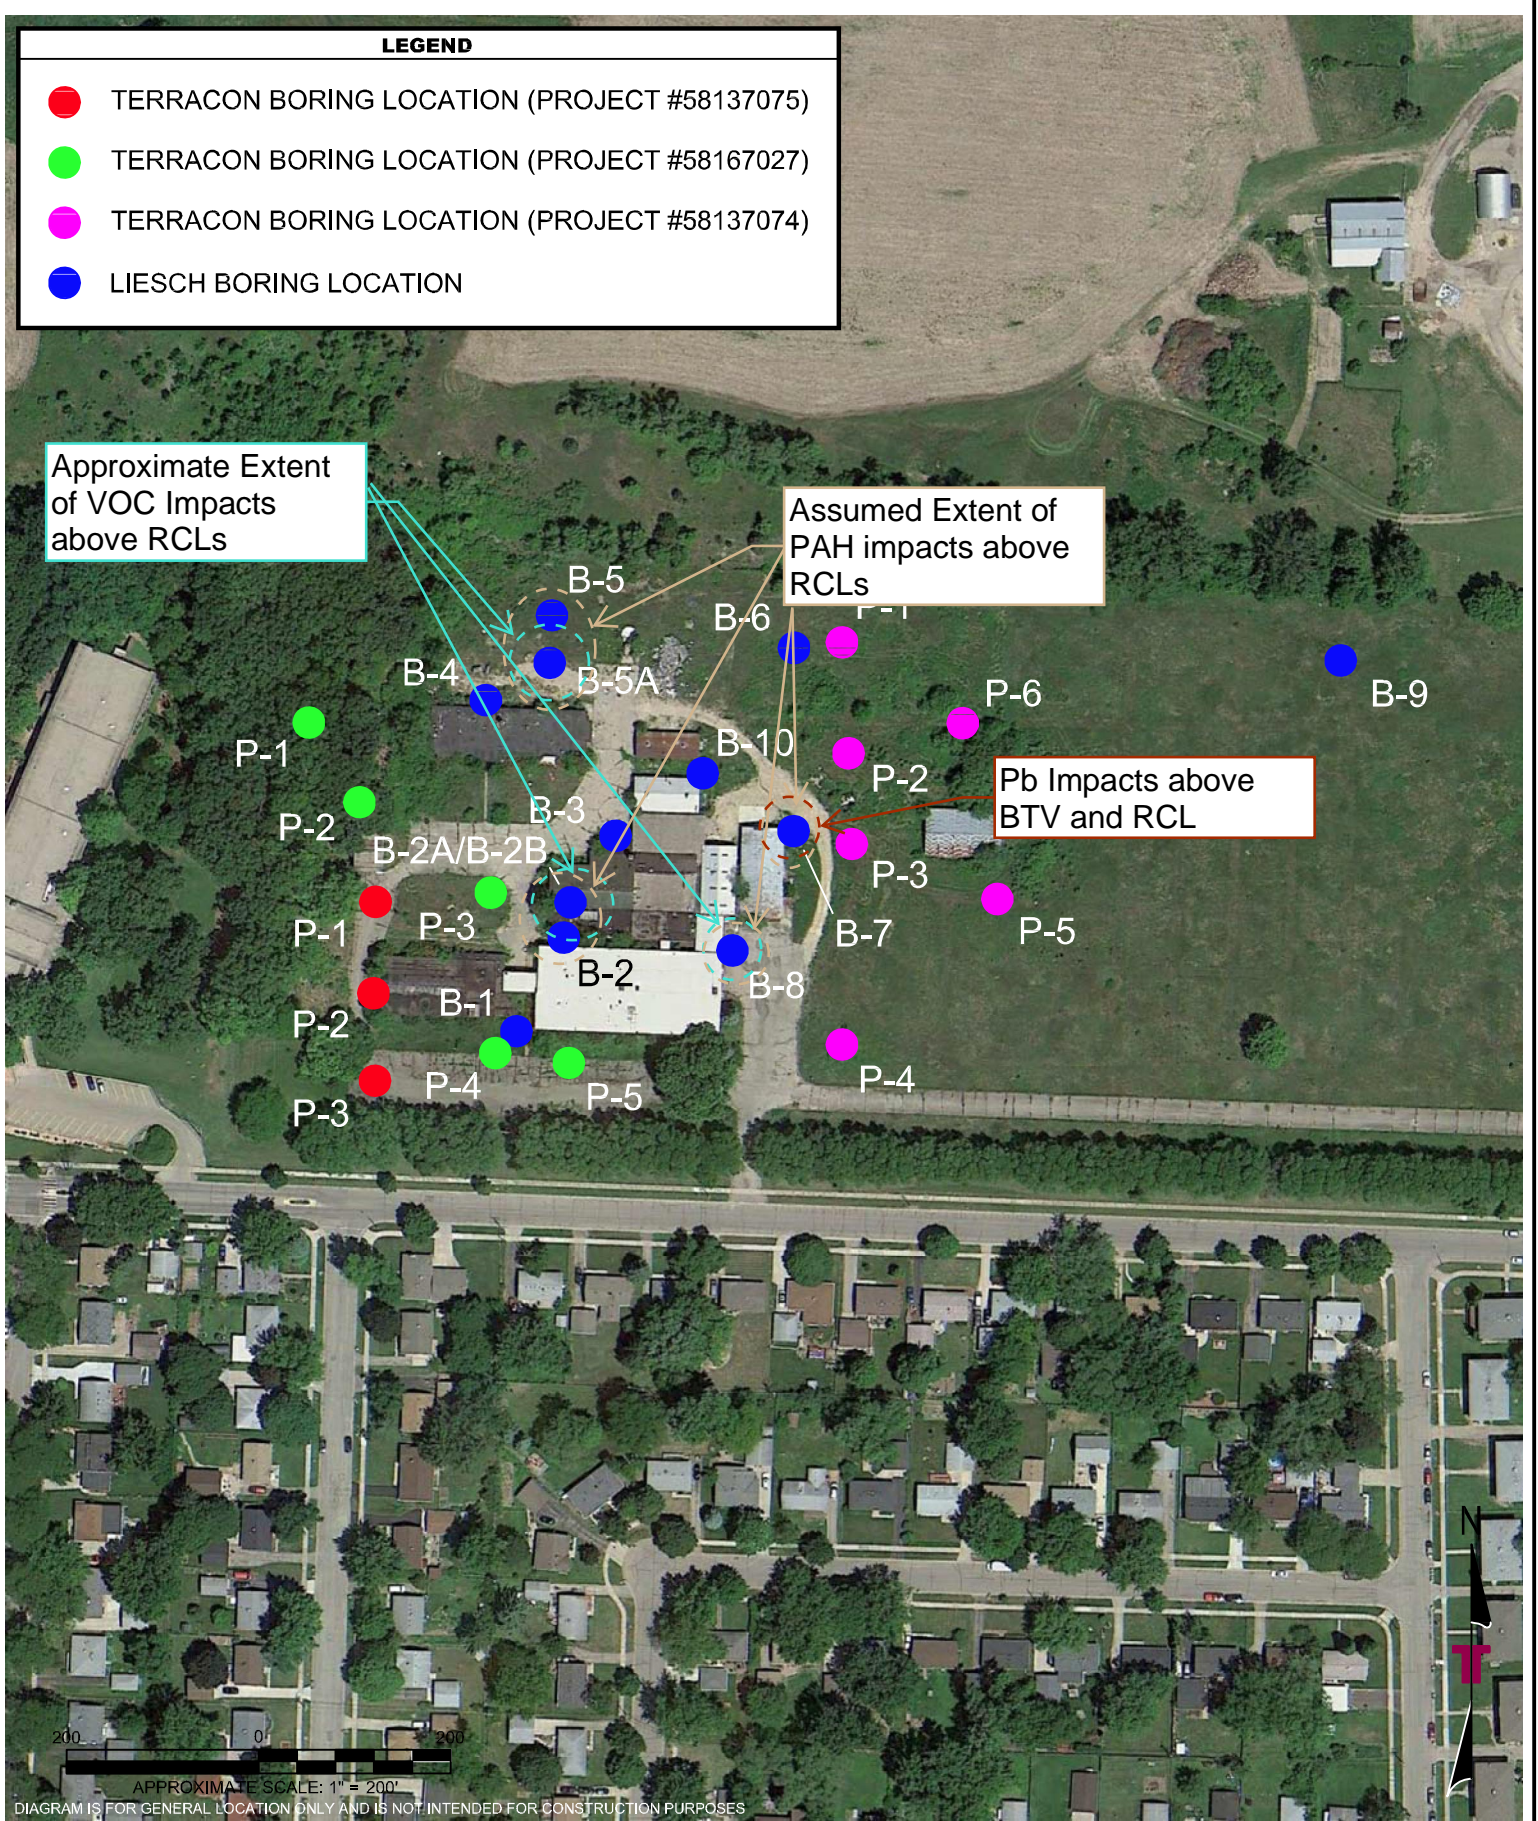
EXHIBIT
2
(AERIAL)

Assumed Extent of PAH impacts above RCLs

Pb Impacts above BTV and RCL
