**PHASE ONE  
ENVIRONMENTAL SITE ASSESSMENT**

**1902 TENNYSON LANE  
AND  
3802 PACKERS AVENUE  
MADISON, WISCONSIN 53704**

**October 2005**

**JN: 6201317.00**

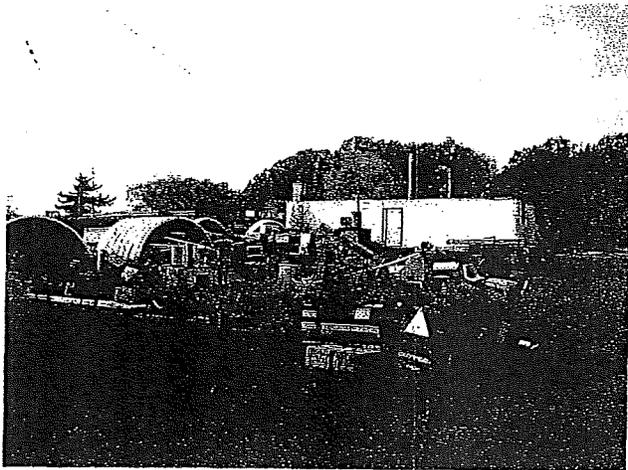
31 - Former fueling station at center, north of Buildings 7 & 9

- Building 7, AST and UST, north side of the building and west of center, removed, closure conditions not reported.
- ~~Former fueling station~~, one UST, approximately 50 to 75 feet north of Building 9, gasoline, removed, closure conditions not reported.

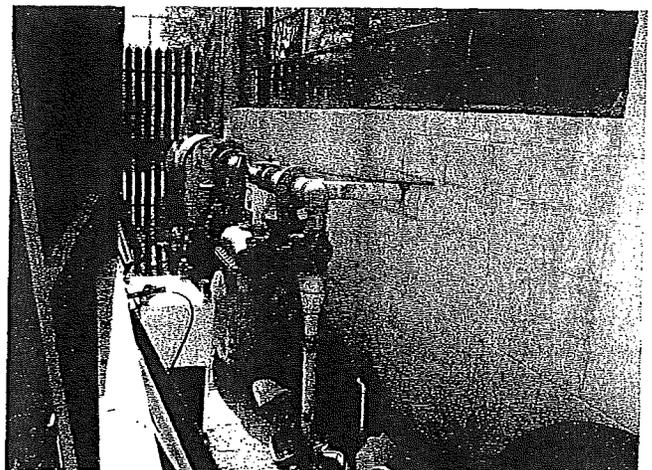
32 - AST between Bldgs. 1 & 2, south side

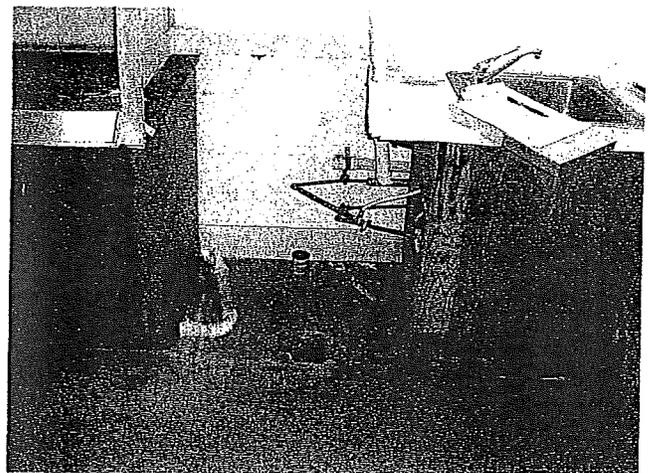
34 - UST pipe, Bldg. 3, south wall, west end

- Properly abandon and close unused USTs and ASTs in accordance with state and federal regulations, including collecting soil samples for analysis of petroleum products and hazardous wastes.

Building 3: A fill pipe for a UST was observed along the south wall near its west end, along with another capped pipe located inside the building in the floor which appeared to belong to the same UST. The former use of the UST was not reported or apparent. A fill pipe for a second UST was observed from the east-side loading dock in the alley between Buildings 2 and 3 and on the west side of the passageway between Buildings 2 and 3; the location and size of the UST was not reported or observed, but it reportedly was used for fuel oil. This second UST was reported by the Property owner to have been filled with approximately 800 gallons of fuel oil at one point in time and was not emptied when its use was discontinued circa 1996, when the heat source for Building 3 was switched to the boiler located in the southeast corner of Building 1. A third UST reportedly was removed from a site on the northwest side of Building 3, along the north wall located west of the auto repair shop (located in the northernmost portion of Building 3). This third UST reportedly served a boiler located in Building 3 near the location of the UST but not used by the current Property owner.

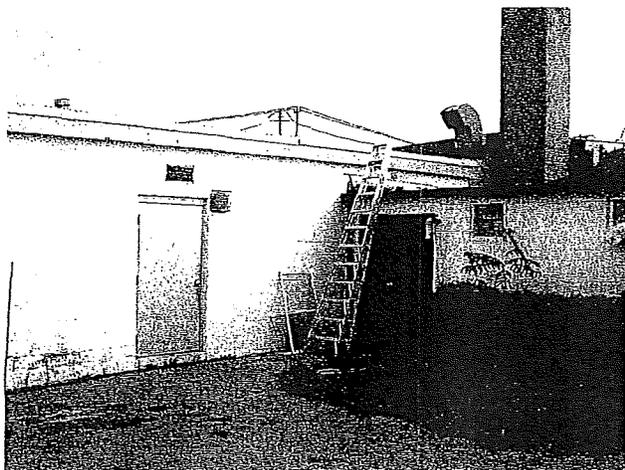
35 - Bldg. 3, NW exposure, former UST site at right

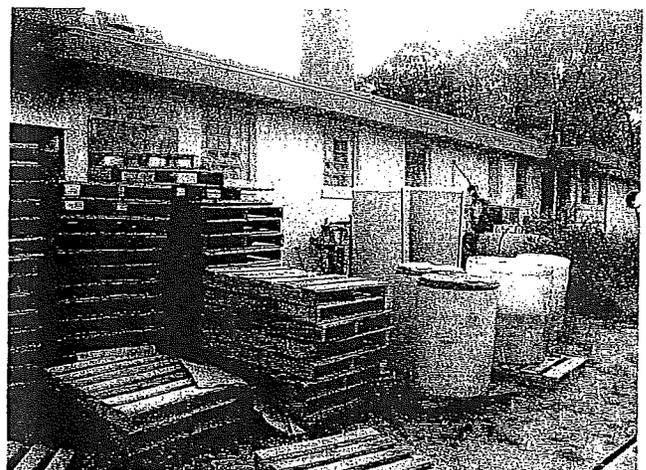
36 - Bldg. 7, north side, former UST/AST site behind unknown drums

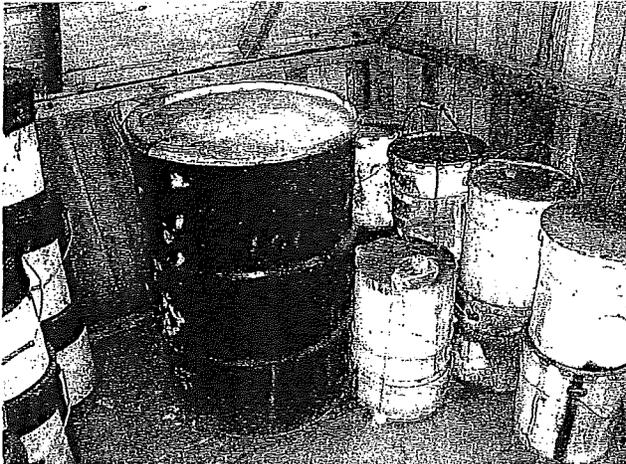
27 - Chicken shed, enamel paint and unknown drum contents

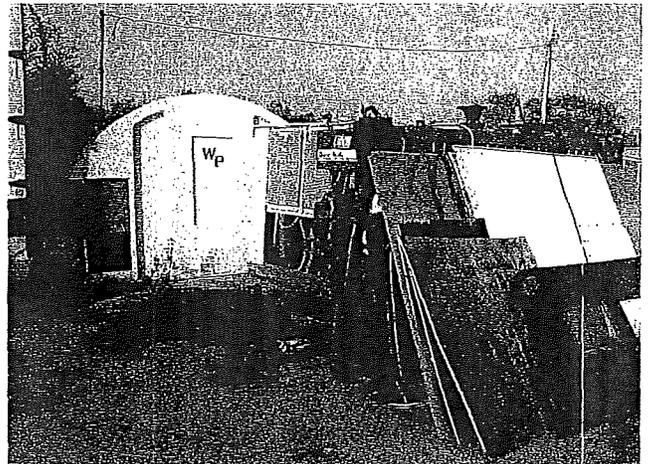
- Several ASTs that appeared to be empty also were observed among the miscellaneous salvage/storage items. One AST that appeared to contain liquid was located among the store items north of Building 7 and behind a curved Quonset end-panel.

28 - Stored items north of Bldg. 9; AST behind door at left

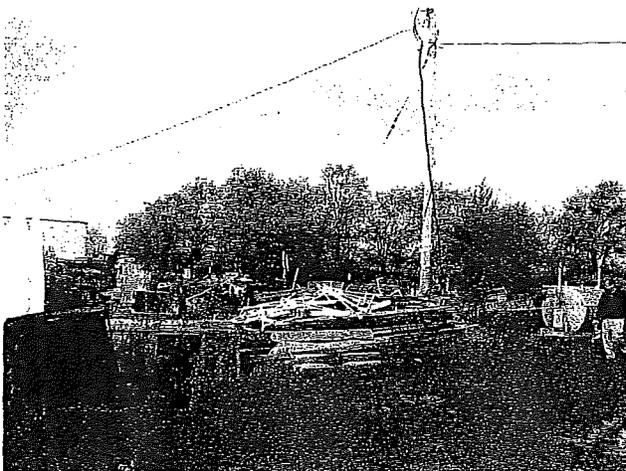
- The grounds north of the buildings contain many various items that are stored for salvage or reuse. In addition to the material threat of release of hazardous substances and/or petroleum products observed, reported, and noted above, these items may represent a perception of environmental contamination that could affect the material and/or regulatory conditions for the Property, in addition to unreported and unobserved environmental conditions of the stored items.

29 - Typical salvage materials storage

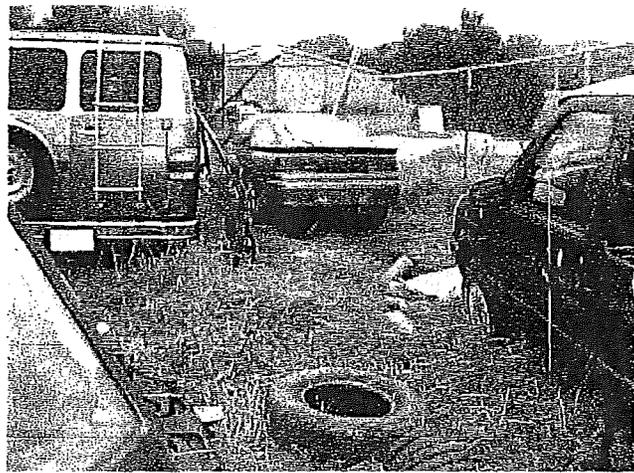
- A floor drain observed in the auto shop in Building 3 and a storm grate observed outside near the overhead door discharge via drain tile to the soil surface north of Building 5. The storm grate reportedly contains a grit-and-oil catch-basin constructed with a 55-gallon drum filled with sand and buried at the site that serves as a filter prior to surface discharge. However, this device was not observed for evidence of leakage, and the discharge area at the end of the drain tile was observed to ~~contain oily stains that indicated release of unknown substances~~.

14 - Bldg. 3 storm grate outfall, east of auto shop

- Collect and analyze samples of shallow surface soils in the vicinity of stored motor vehicles, the large surface stain noted north of Building 7, and the discharge area for the drain tile serving the auto shop to assess these areas for presence of petroleum products and hazardous wastes.

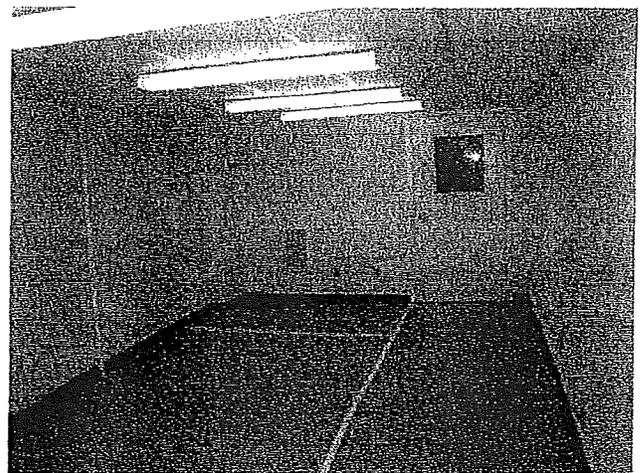
12 - Bldg. 3, Chemical storage room

- Develop an inventory of hazardous substances, including solvents, petroleum products, paints, biological agents, and other substances, to provide a basis for proper handling and disposal prior to demolition.
- Develop a method of managing infectious substances associated with prion research currently conducted on the Property.
- Dispose of used fluorescent lamps and high-intensity lighting in accordance with current federal, state, and local regulations.
- Replacement, recharge, and/or dismantling of the numerous HVAC units should be performed by an EPA-certified contractor or individual.
- Contact U.S. Nuclear Regulatory Commission to determine the nature, history, and status of radioactive materials under the license held by Wisconsin Radiological Labs, Inc., a former tenant of the Property.
