**AAI PHASE I ENVIRONMENTAL SITE ASSESSMENT**

**FORMER OSCAR MAYER PLANT, NORTH END  
910 OSCAR AVE  
MADISON, WISCONSIN**

**PROJECT REFERENCE #19174**

**MAY 2020**

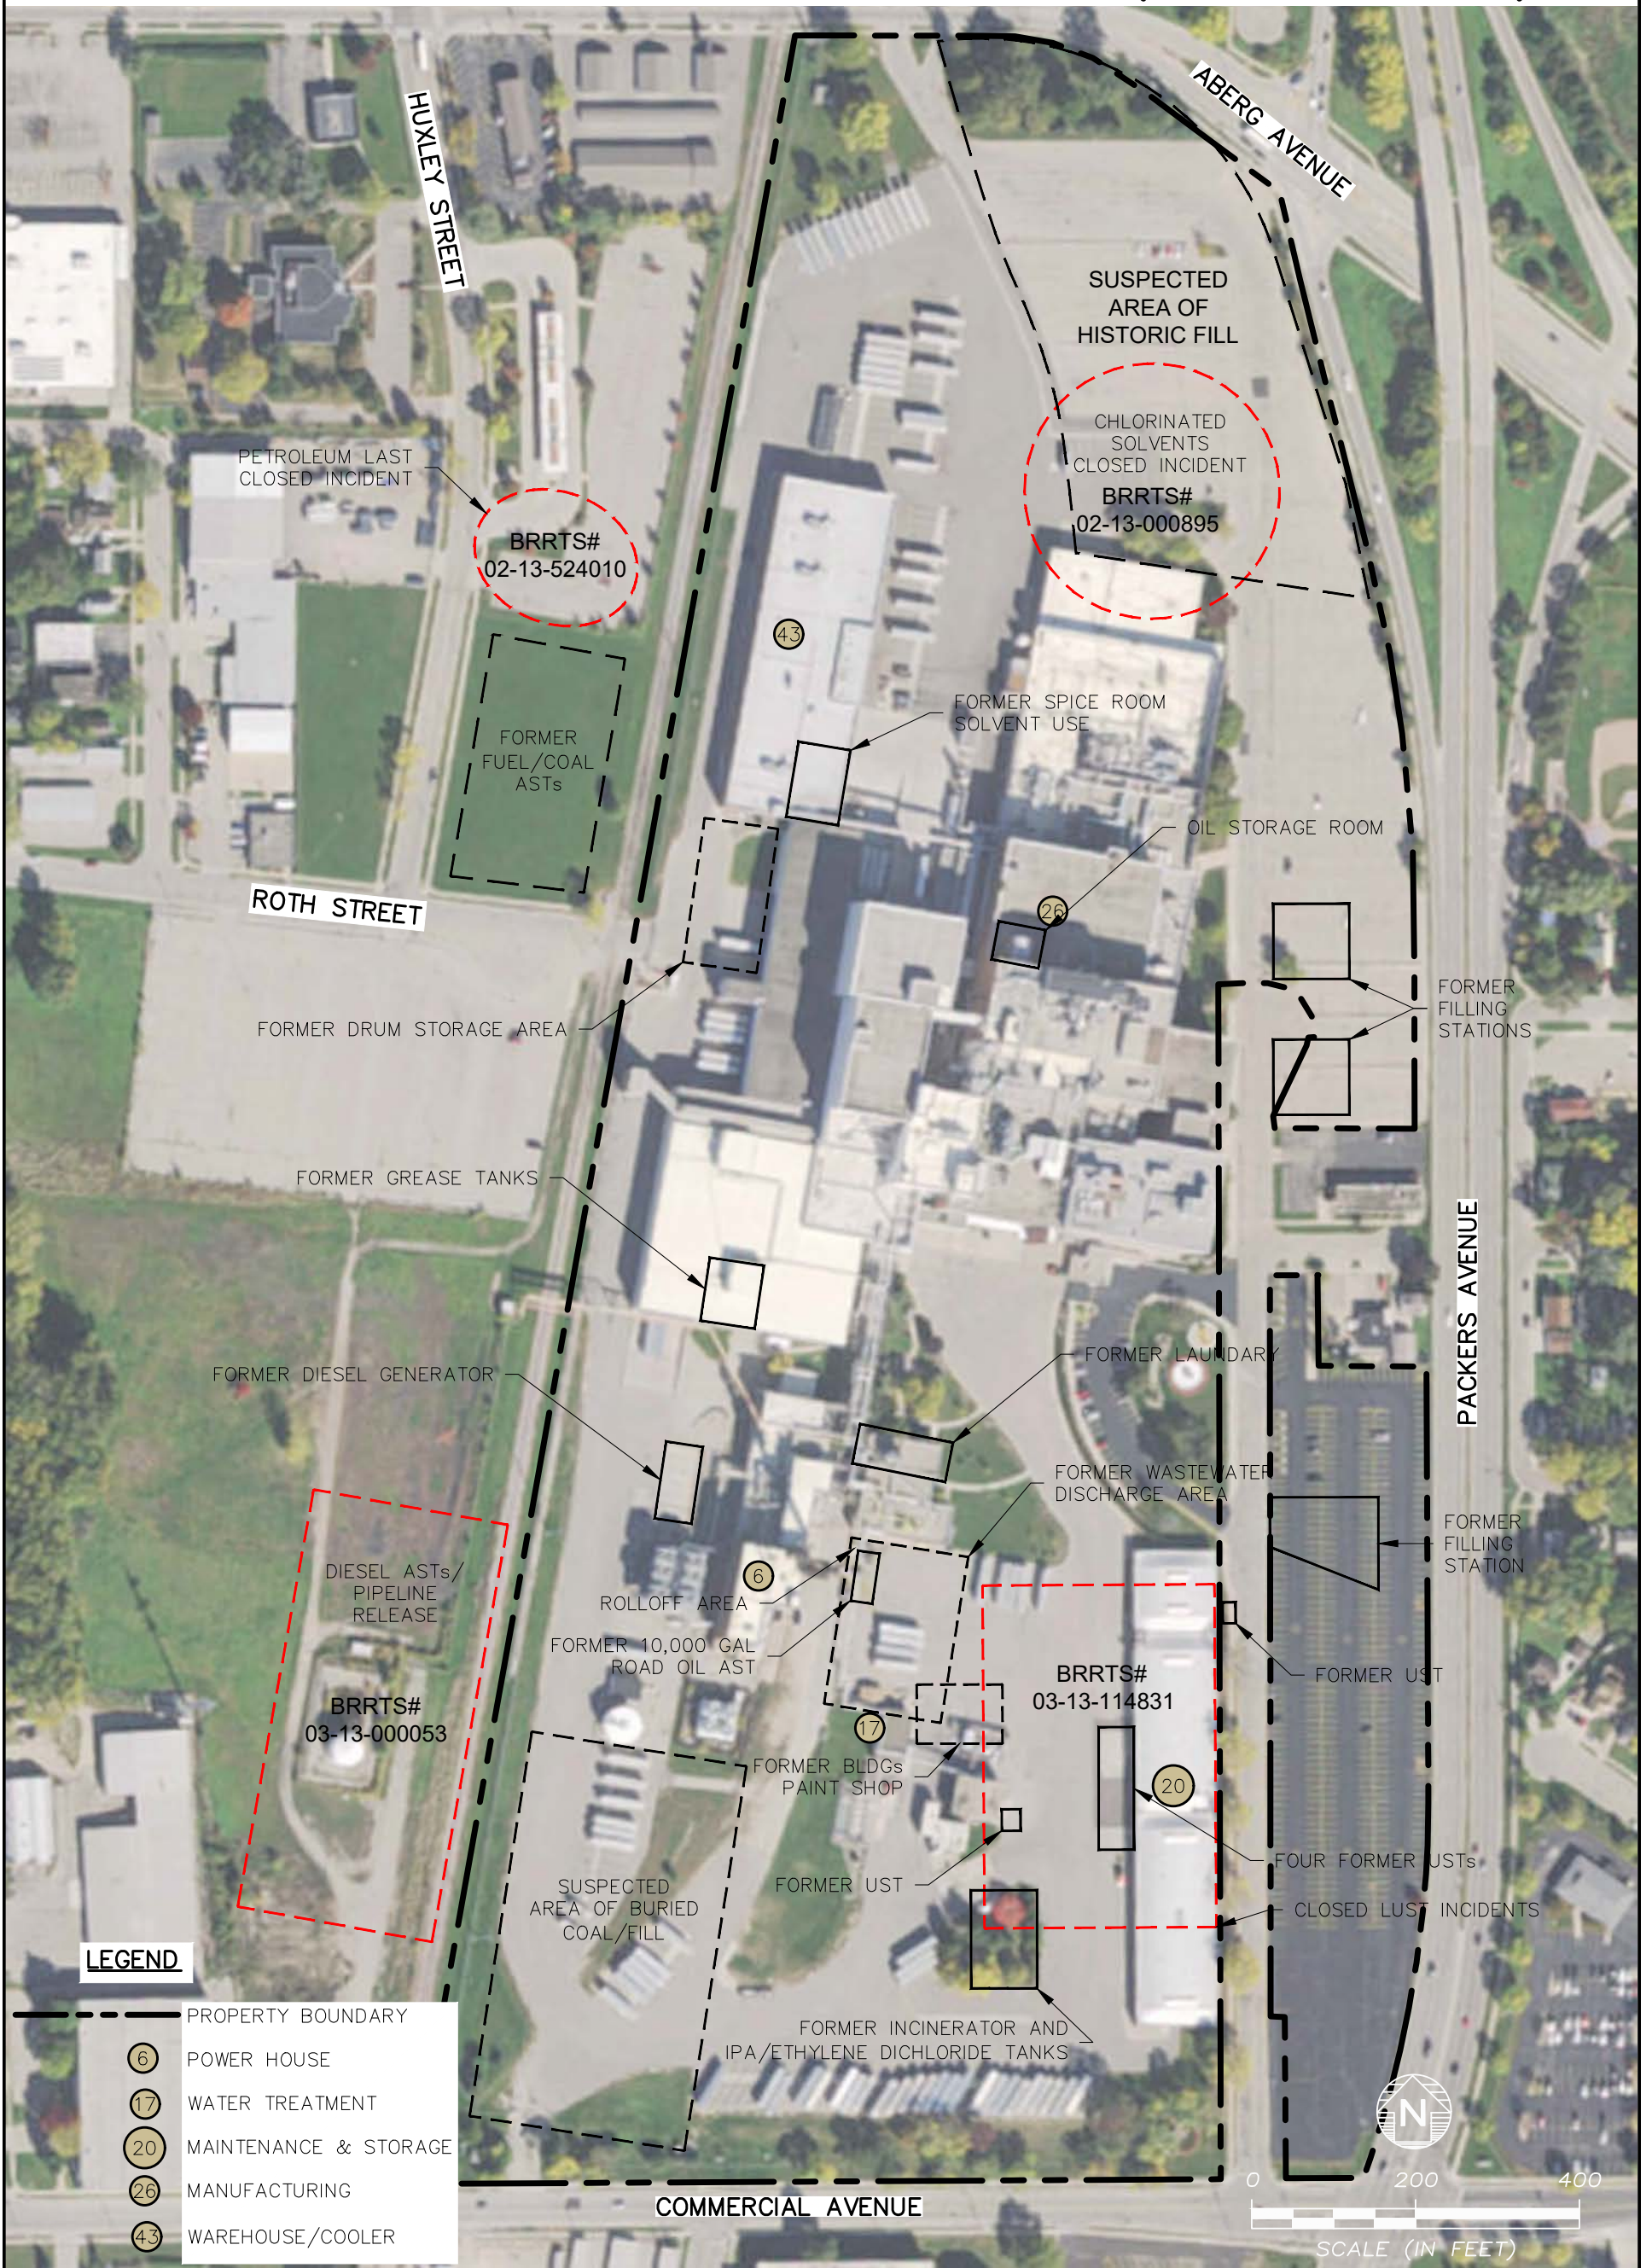
FIGURE 3

# PREVIOUS ENVIRONMENTAL CONDITIONS (2017 PHASE 1)

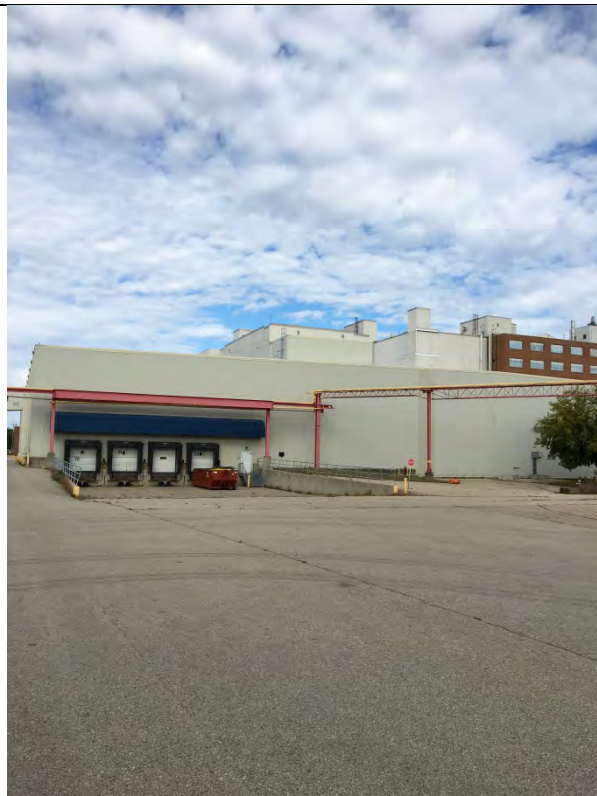
**Photograph: 7**

Photograph outside of water treatment equipment building. This area was formerly used as a collection area for 55-gallon drums of various chemicals during decommissioning activities.

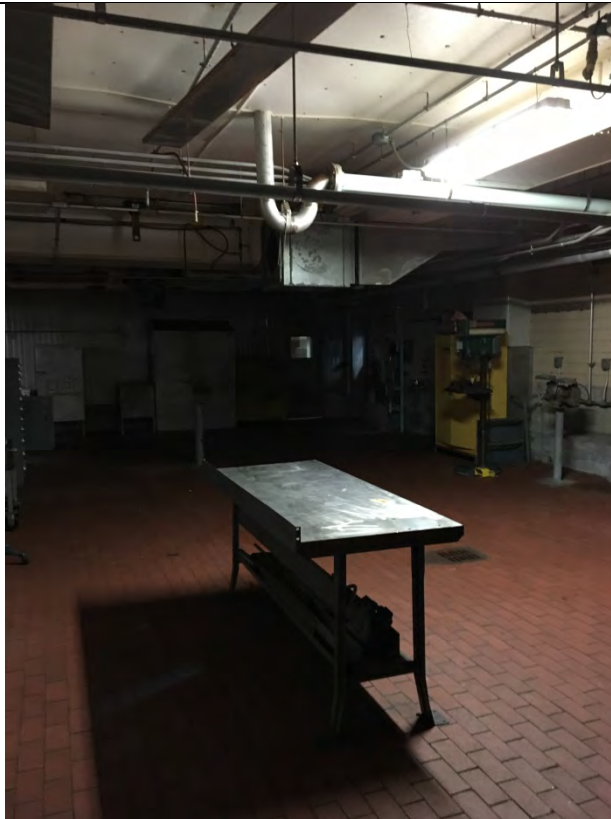
**Photograph: 9**

Former maintenance area on the ground floor of the manufacturing facility. This representative of maintenance areas observed throughout the facility by ERM.

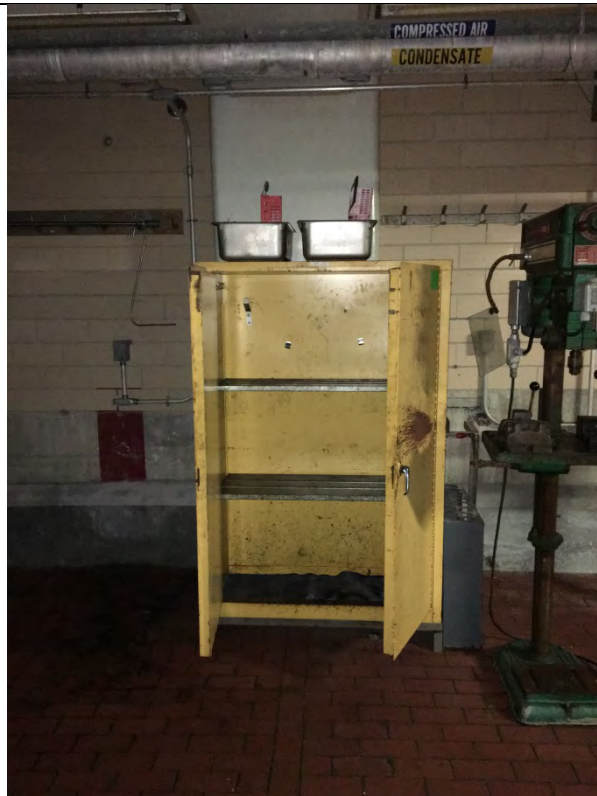
**Photograph: 10**

Empty flammable material cabinet in former maintenance area. This is representative of flammable material cabinets observed throughout the facility by ERM

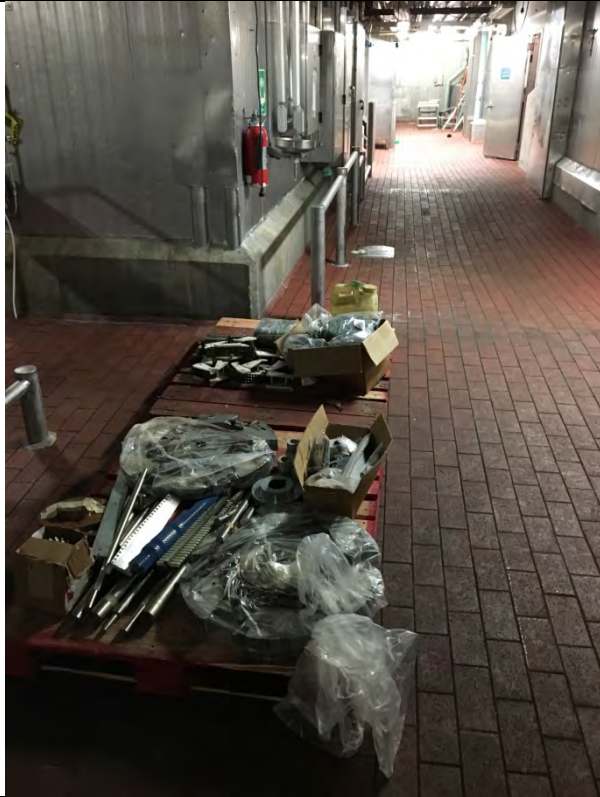
**Photograph: 13** Wood pallet of miscellaneous materials in former manufacturing area. ERM observed several of these pallets throughout the facility.

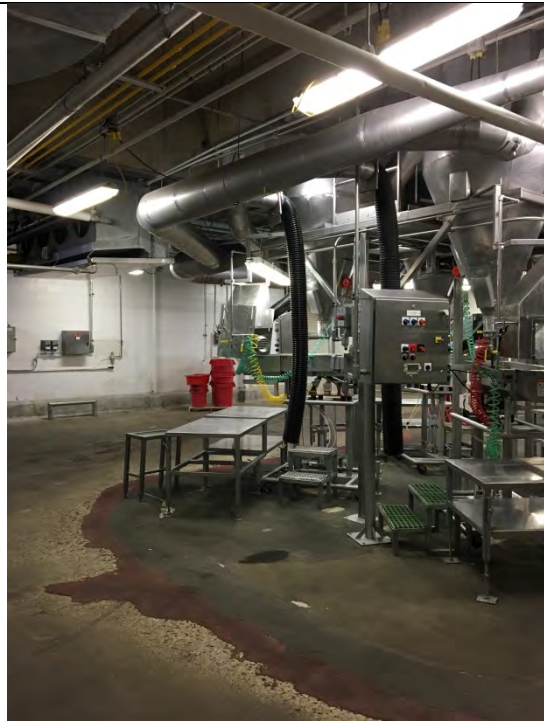
**Photograph: 14** Manufacturing area. Representative of manufacturing areas observed by ERM throughout the facility, the area was generally cleared out with equipment remaining.

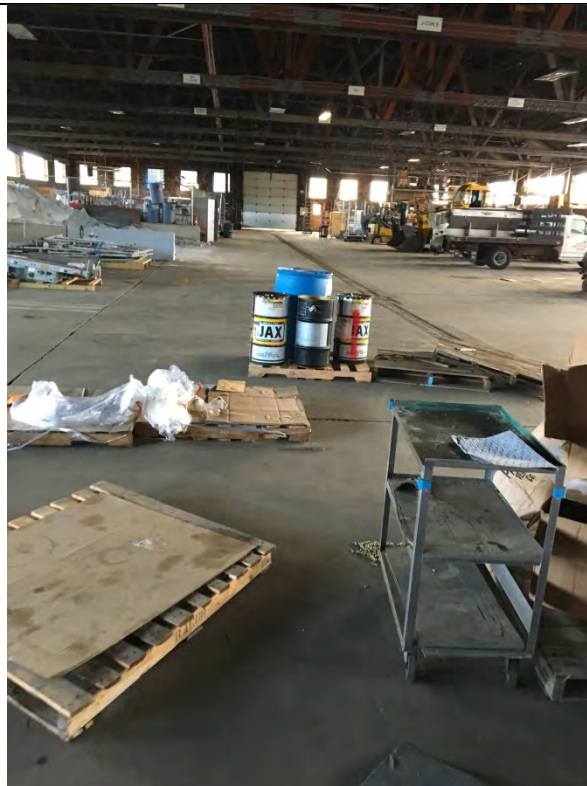
**Photograph: 16** Inside of Building 20 area used during decommissioning activities to collect chemicals and hazardous materials. Several, empty containers and wood pallets remain.
