RE: SPMD Water Quality Sampling of Starkweather Creek

FreshWater Engineering is pleased to submit this report for the Semipermeable Membrane Device (SPMD) Water Quality Sampling Study of Starkweather Creek.

SPMD Water Quality Sampling Starkweather Creek

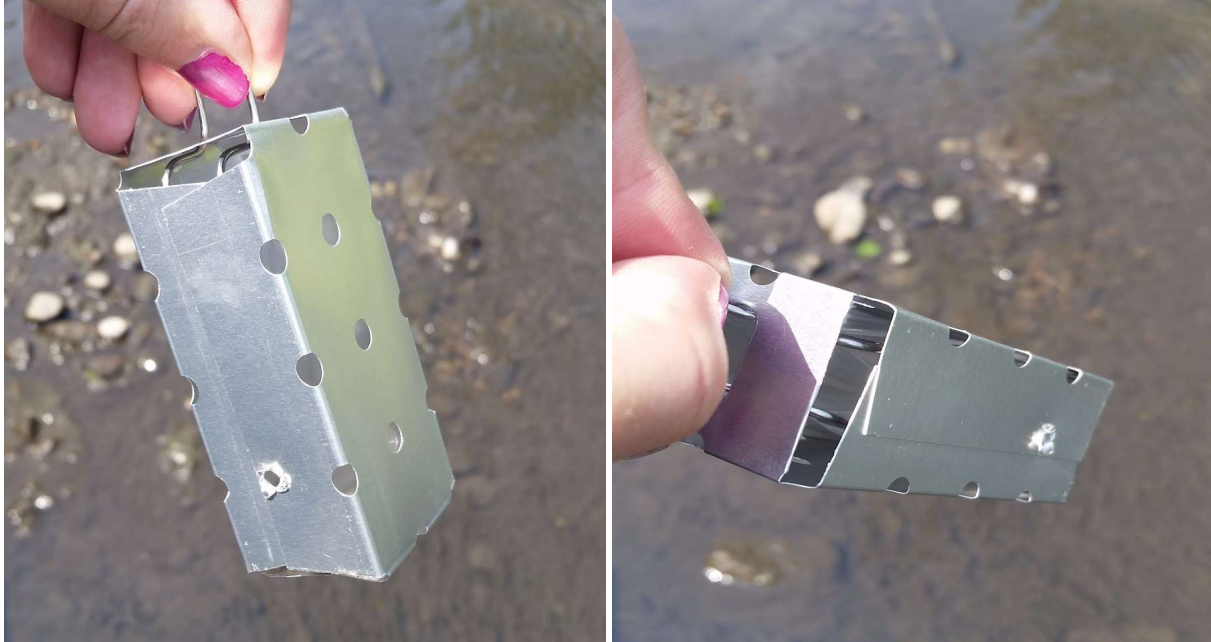
Figure 1: SPMD sampler in protective case during field deployment

SPMDs are flattened tubes of low-density polyethylene filled with a thin layer of triolein, a neutral lipid that is found in most aquatic organisms (Figure 1). They provide a long-term, stationary sampling point by being fixed to the streambed during deployment, which allows contamination sources at different sections in the creek to be identified. SPMD study results are highly reproducible, can be standardized over different seasons and sites, and can be compared to results from other river and stream studies using SPMDs.

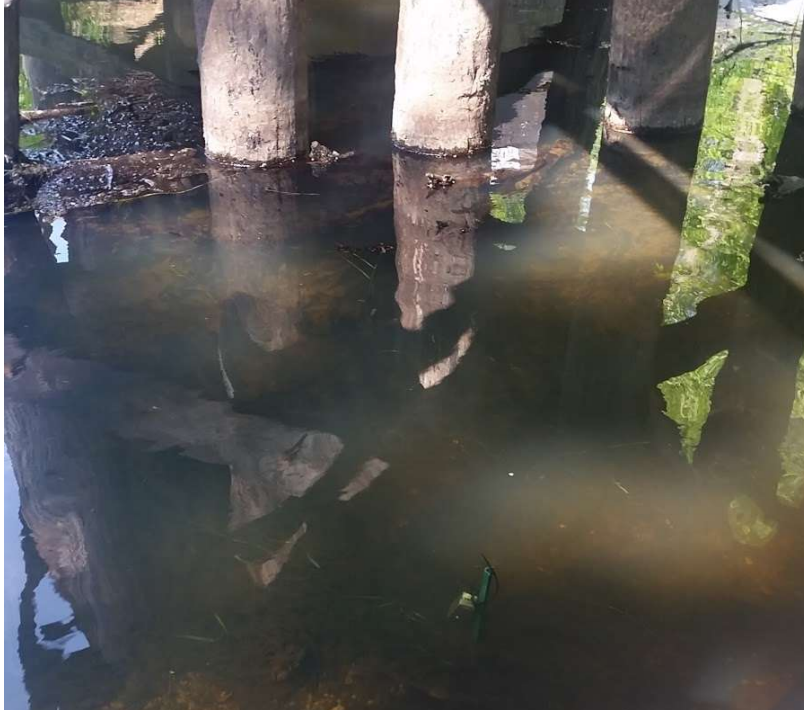
Figure 4: SPMD deployment at West Branch Milwaukee Street location

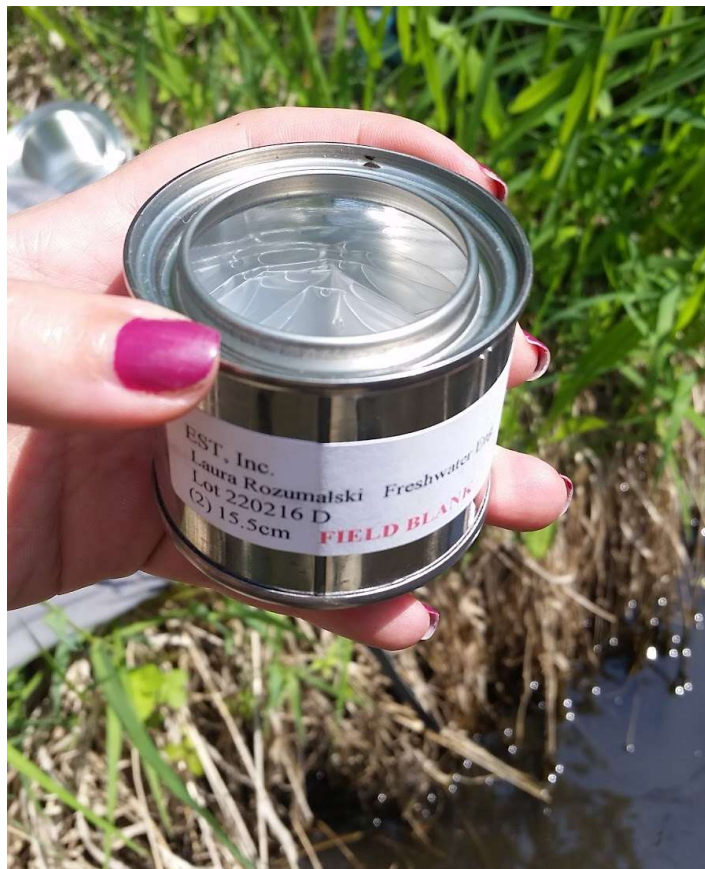
Figure 5: Field blank exposed to air at each site during deployment and retrieval

The trip blank, or control sample, was exposed to the atmosphere during SPMD deployment and retrieval, for a total exposure time of roughly 10 hours. The toxicity of this sample serves as a benchmark to compare to other site toxicities. Here, it is interesting to note the “Above Airport” sample had less toxicity than the trip blank sample, indicating there is likely a high impact on the creek coming from atmospheric sources.

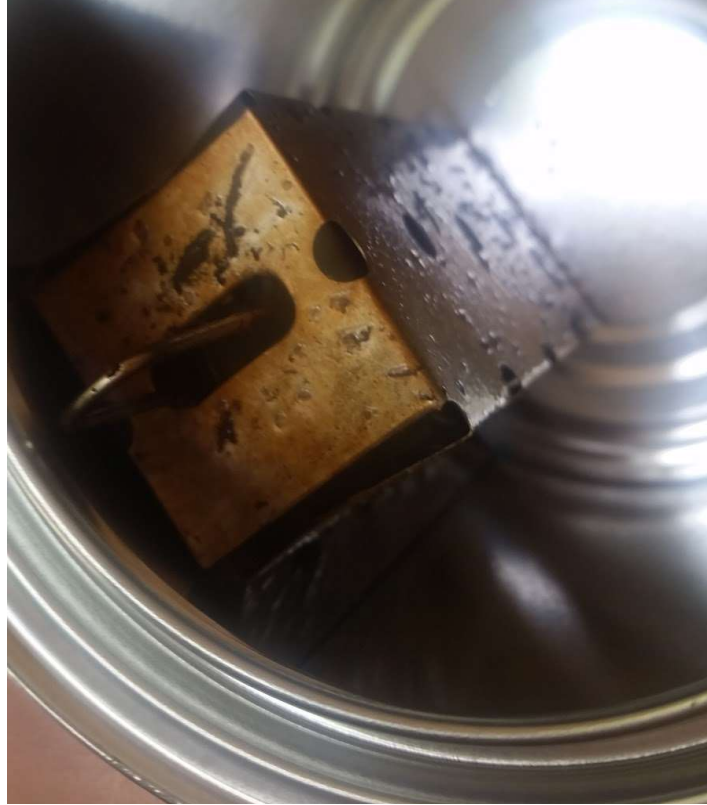
Figure 6: Typical biofouling buildup on SPMDs during deployment, observed during retrieval

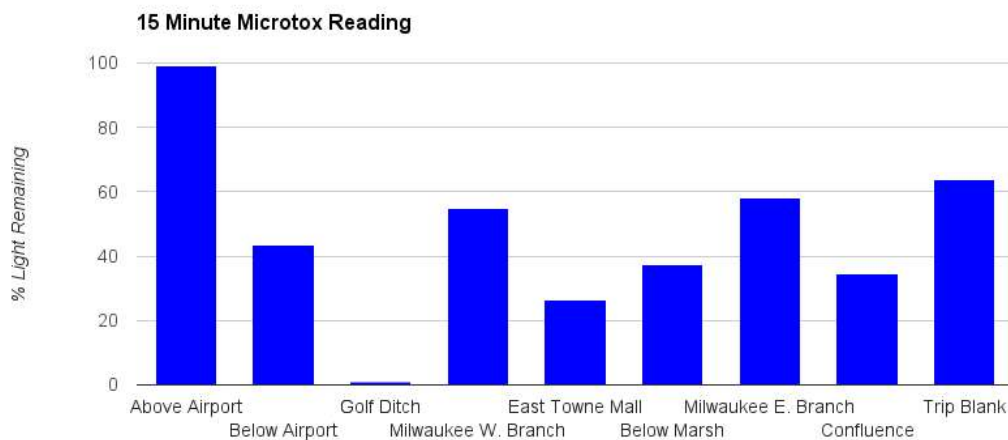
The results from the Microtox analysis are illustrated in Figure 7. As noted, the relative toxicity between sites can be determined by comparing the bioluminescence values. The percent light remaining indicates how toxic the sample was, the higher the percent light remaining, the lower toxicity that exists. For the sample results, the least toxic sample (highest relative amount of light remaining) and therefore the site with the best water quality within the creek was just upstream of the Dane County Regional Airport (Above Airport site).

Figure 7: 2016 SPMD Microtox results

The golf course ditch was the area of worst toxicity with a reading of 1% light remaining. The “East Towne Mall” had the next highest toxicity, followed by the “Confluence” site and the “Below Airport” site. One improvement to notice is from the “East Towne Mall” location to the “Below Lien Marsh” location. As Starkweather Creek flows downstream through the marsh, the water quality improves, which indicates the marsh is acting as a natural water treatment area.

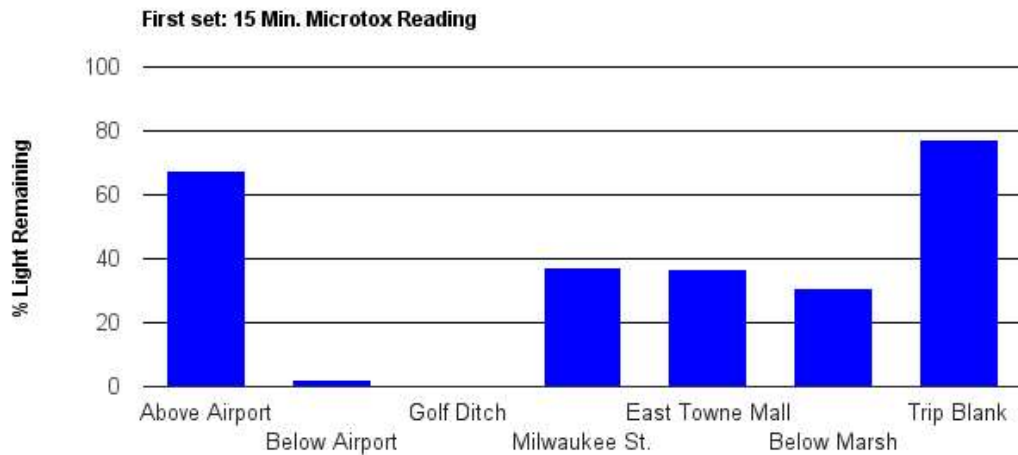
The study done in 2005 by the UW-Madison Water Resources Management Practicum students can be directly compared to the 2016 study results. In 2005, the first round of SPMD samplers were deployed for 30 days beginning April 20, 2005. Over this period, the Starkweather Creek watershed received 3.85 inches of rain (National Climatic Data Center, 2006). Results are illustrated in Figure 8.

Figure 8: 2005 Microtox results from first round of sampling

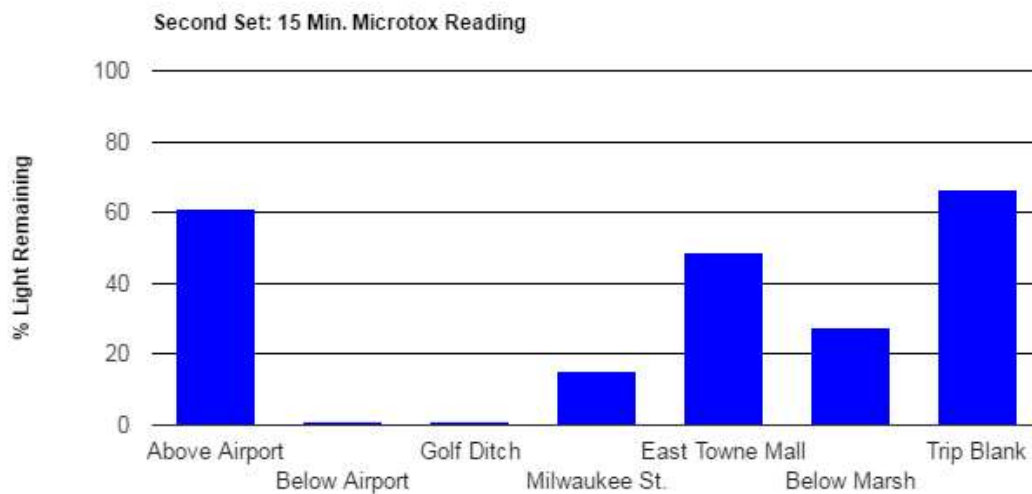
The second round of SPMD samplers during 2005 were deployed for 30 days beginning on June 22, 2005. During this time, 2.97 inches of rain fell on the watershed (National Climatic Data Center, 2006). Results are illustrated in Figure 9.

Figure 9: 2005 Microtox results from second round of sampling

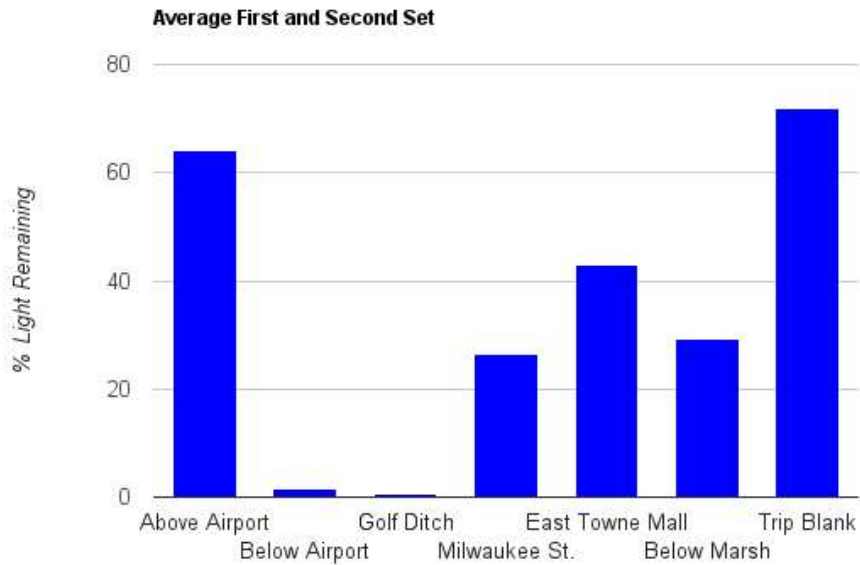
For comparison to the 2016 study results, the Microtox test results from the two rounds of sampling were averaged at each sample site. The graph in Figure 10 depicts the averaged results.

Figure 10: Averaged 2005 Microtox results

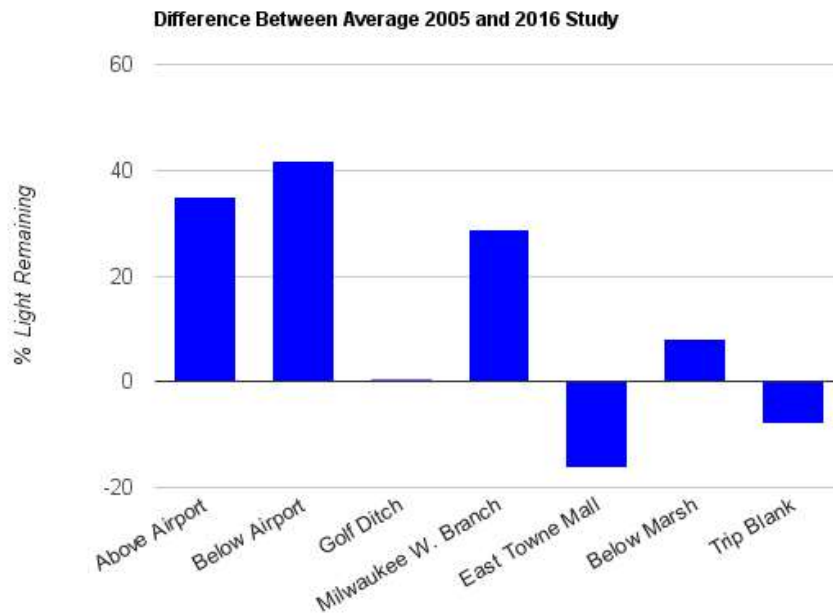
The averaged data from 2005 and the new data from 2016 are compared in Figure 11 and Figure 12. In Figure 11, the 2005 results values are subtracted from the 2016 values. A positive value indicates water quality has improved and a negative value indicates it has declined. The only in-stream sampling location that declined was the “East Towne Mall” location, but the toxicity of the trip blank, which sampled air quality, also decreased. All other locations saw an increase in water quality, though the Golf Course site only saw a very small improvement. The site below the airport saw the greatest increase in water quality. Figure 12 shows the toxicity values from each of the sample locations without averaging.

Figure 11: 2005 and 2016 studies - result comparison

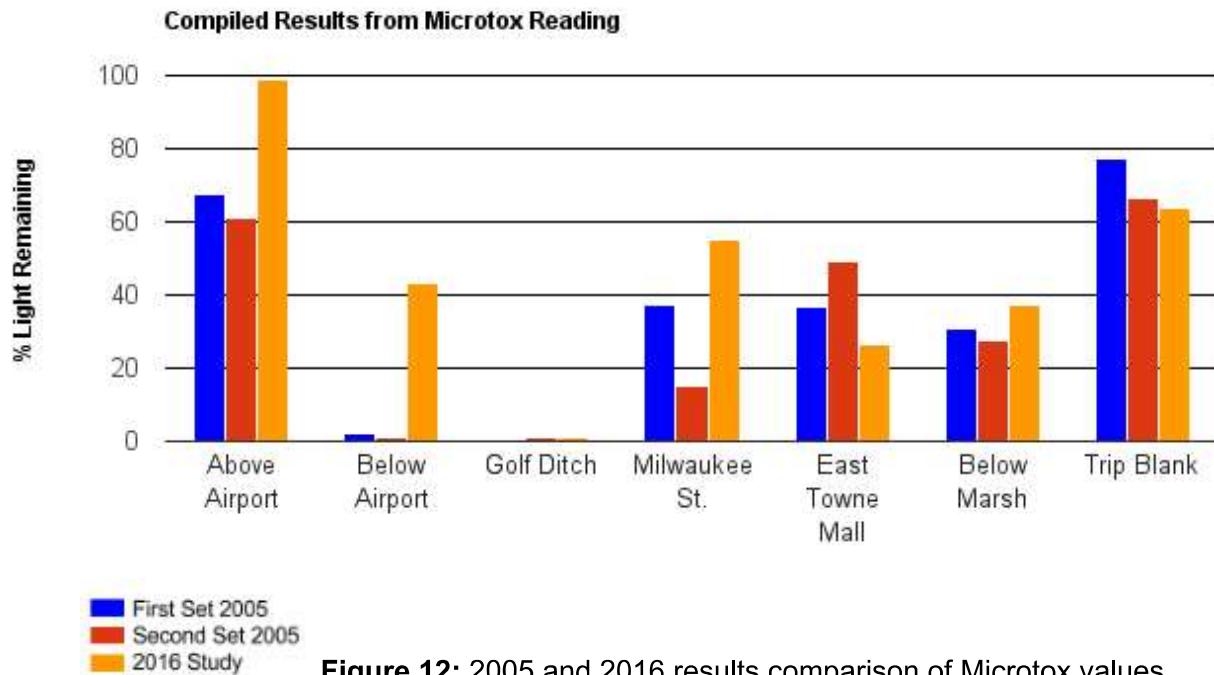
Figure 12: 2005 and 2016 results comparison of Microtox values

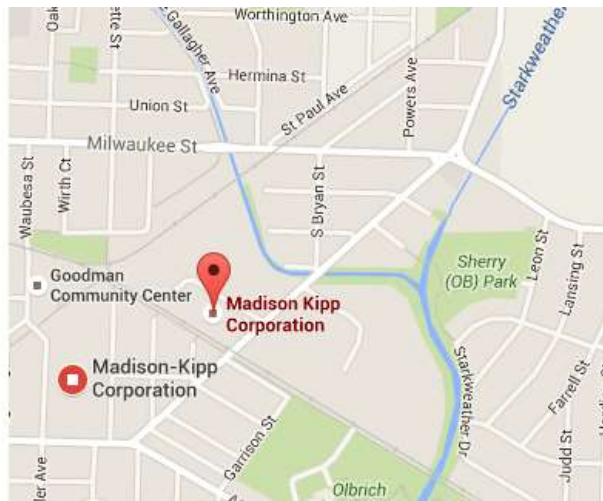
MKC facilities in relation to Starkweather Creek
