## 1902 Tennyson Lane Hazardous Materials Survey Summary 11/18/2011 Site Visit

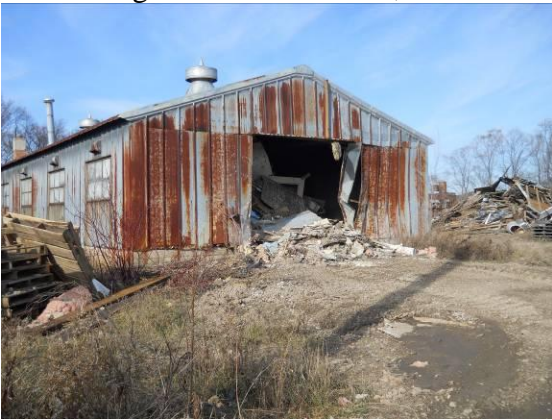
The survey consisted of a quick walkover of the buildings as we attempted to visually scan all of the rooms of the facility. The main facility of the building was secured with the exception of the loading area. We were able to survey all but one of the remaining outbuildings and the loading dock area of the main building. The one outbuilding we could not enter, was filled with what appeared to be demolition debris.

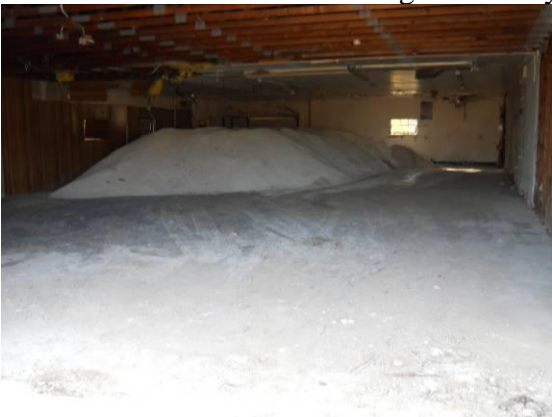
Salt in loading dock area

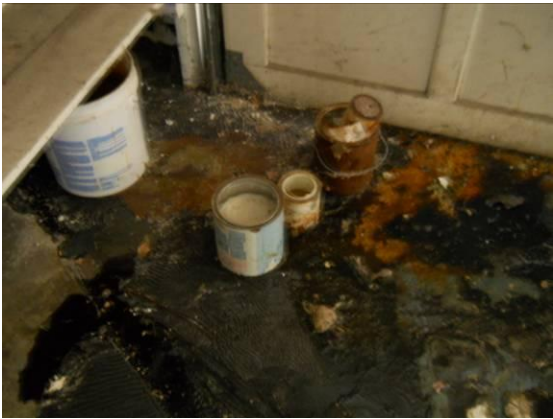
Material behind salt pile in loading dock area.

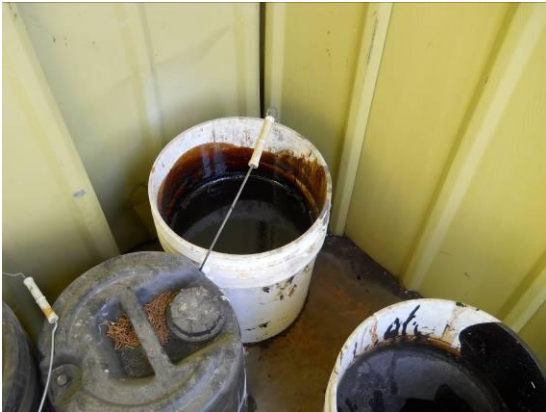
Materials outside of loading dock area in entryway.

- A small “dorm size” refrigerator with unlabelled chemical in glass bulb, plus another chemical container was discovered in laboratory room. Since they were discovered in an abandoned refrigerator, they may be temperature sensitive and could be shock sensitive. These chemicals should be handled with extreme care by a hazardous materials professional.
  - **Could not observe, building secured**
- Several containers of hazardous chemicals in 1-quart and 5-gallon buckets were located in the back of the loading dock area (see pictures above).
  - **Most of the materials moved from the building, some left in outside entryway.**

It is my opinion the facility needs to be thoroughly inspected by a hazardous materials inspector to identify and inventory all of the hazardous materials on the property. The hazardous materials need to be appropriately packaged and shipped to an appropriate hazardous waste disposal facility. The facility needs to be secured from the general public as soon as possible to protect people and the environment from chemical releases.

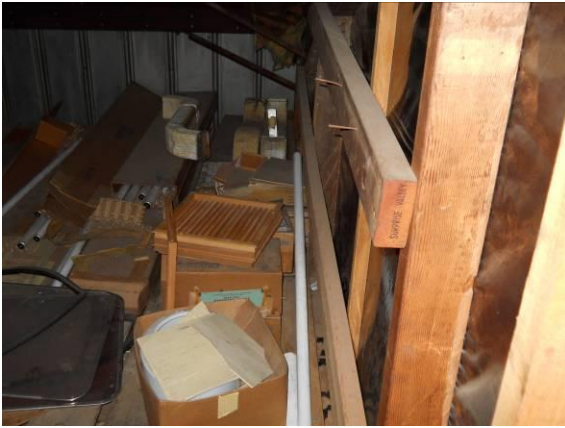
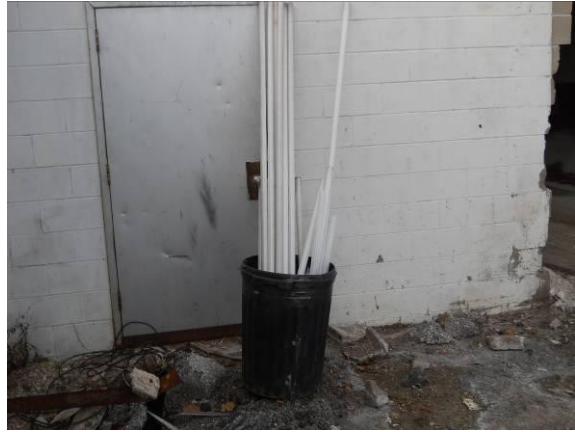
- Broken and intact mercury containing fluorescent tubes were located throughout the facility.
  - **Same observed on re-inspection**

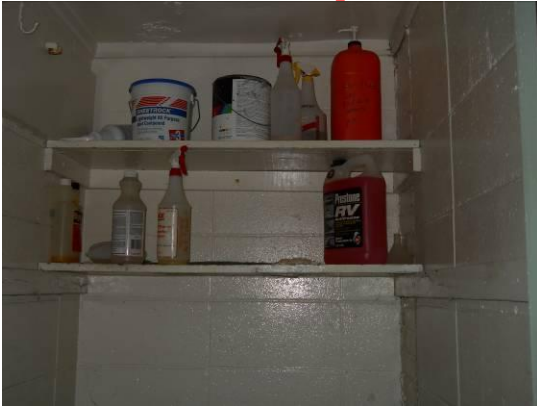
- Several janitor closets with gallon and quart containers of solvents and cleaning materials were discovered.
  - **Same observed on re-inspection**

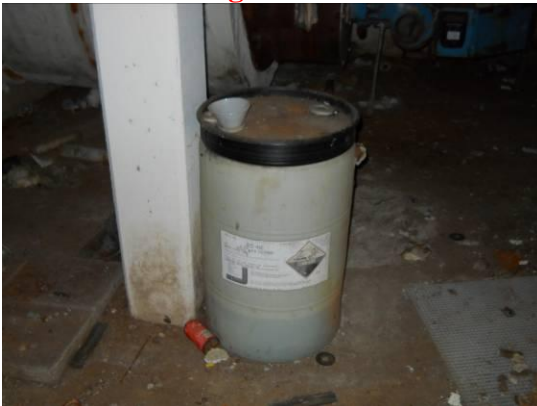
- Two boiler rooms with 55-gallon and 5-gallon containers of caustic boiler chemicals and possible asbestos containers were observed.

- **Same observed on re-inspection; however, we were not able to observe the boiler room in the main building**

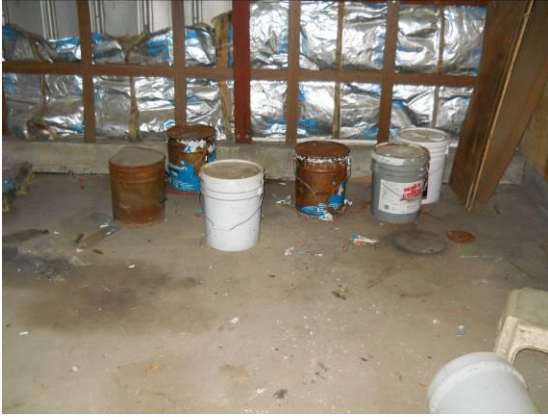
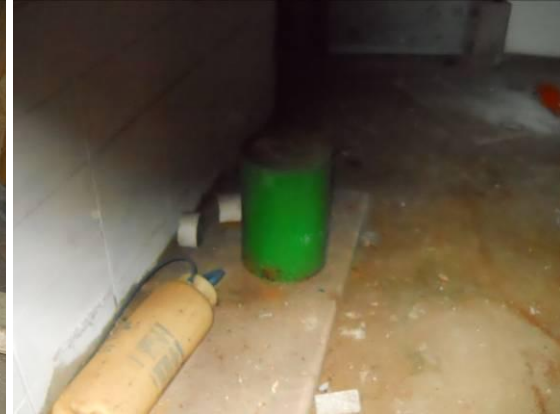
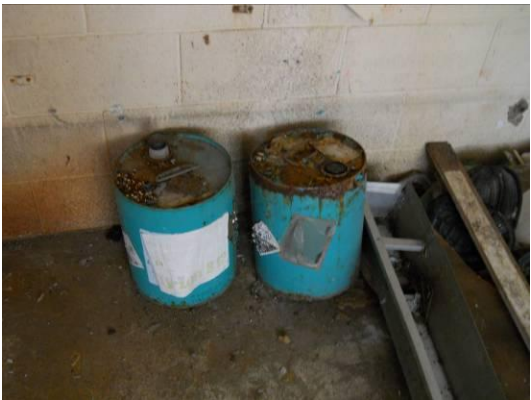
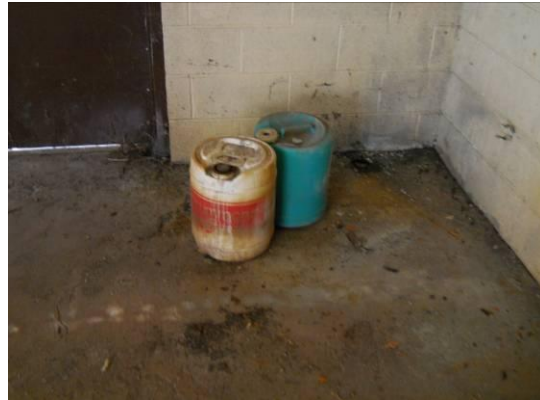
- Various 5-gallon and 1-gallon containers of chemicals were found at various locations throughout the building, many of which contained hazardous materials.

- **Same observed on re-inspection; however, we were not able to observe the main building**

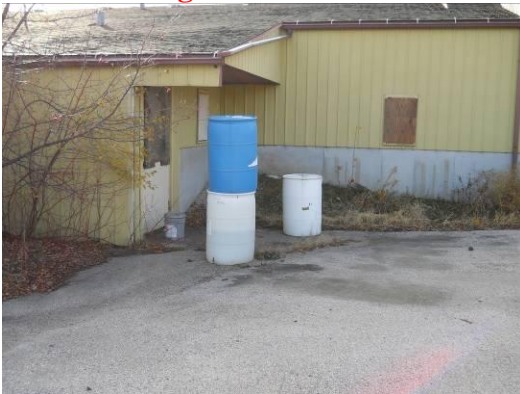
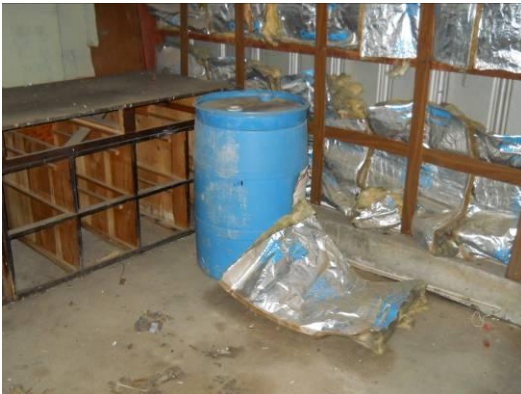
- 55-gallon plastic drums were located inside and outside of the main building, several containing various amounts of unknown liquid chemicals.

- **Same observed on re-inspection; however, we were not able to observe the inside of the main building**

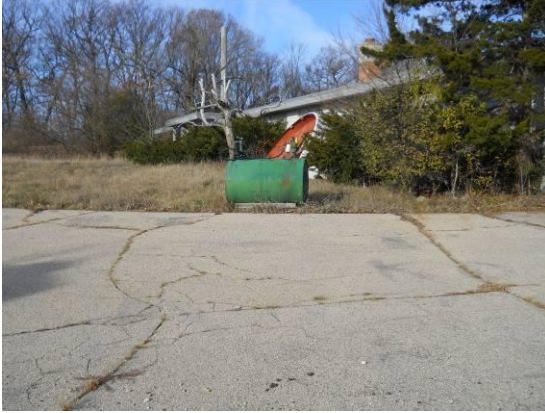
- An above ground storage tank (approximately 200-gallons) was observed outside of the main building.
  - **Same observed on re-inspection; however, we do not know of the tank contains material.**

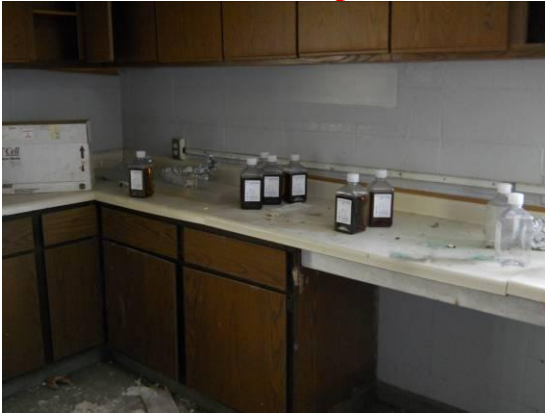
- Several containers of cell media were located in the kitchen area near the front door of the main facility. This material may not be hazardous.
  - **Same observed on re-inspection**
