# Phase I Environmental Site Assessment

Lot 2 of Proposed Certified Survey Map

Part of 3802 Packers Avenue and 1902 Tennyson Lane

Terracon Project No. 58137831

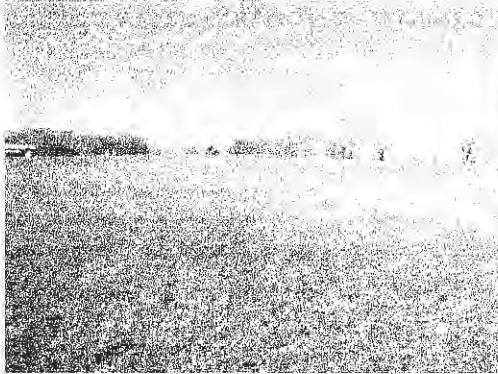
- Grounds in the eastern portion of property were reported to contain “buried animals that were subject to biological experiments in the 1950’s and 1960’s.” This is of some concern, and based on the review of the reports, it cannot be completely determined if an actual REC exists beyond just the burial of animal carcasses. The report indicates two interviews one with the existing owner and a neighbor to the property. Based on the interview section of the Phase I ESA (pg. 13) the subject property was formerly used for research involving chicken diseases, and no detailed information was available regarding specific biological hazards. The interviews also mention that deceased chickens were disposed of in an excavation with specific dimensions. On January 12, 2006, an abbreviated site reconnaissance was conducted by Pioneer on the eastern portion of the site, and the suspected/reported burial site was identified by the surface disturbance (photos).

Eastern Parcel, flat rolling hill, facing West

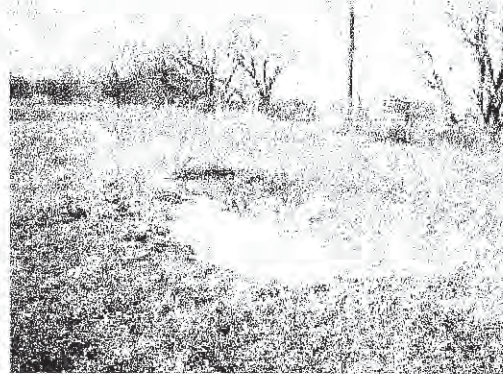
Surface Disturbance –Eastern Parcel NW Corner

The excavation was reportedly 15 feet deep, and the surface disturbance was observed to be at least 10 feet wide and 40 feet long. The boring conducted by Liesch in this area, was not drilled within the excavation and was only sampled for VOCs. Not placing the borehole in the excavation or sampling for any biological agents makes the results inconclusive as to the presence or lack of presence of biological waste or animal carcasses.

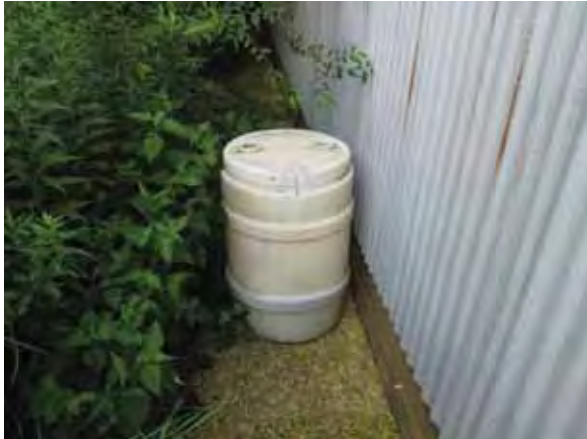
During the site reconnaissance, Terracon observed one plastic 55-gallon drum containing water and debris including plastic, concrete, wood, glass, and metal. Terracon did not identify obvious evidence that petroleum products and/or hazardous substances were spilled/released at the site. The drum and debris should be characterized and properly disposed.

**Photo #13** Plastic 55-Gallon Drum Containing Water

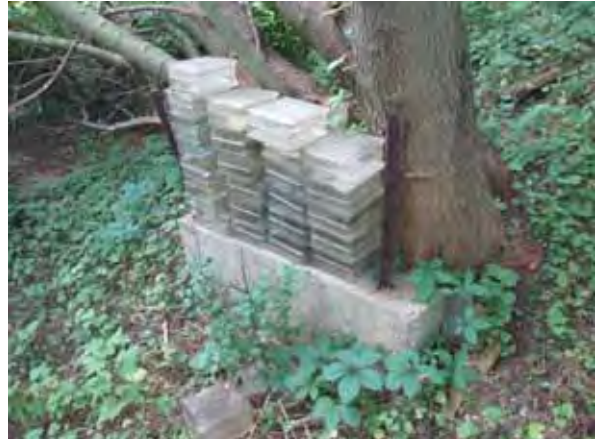
**Photo #14** Debris
