Background for comments #1-3 in “MEJO Comments to City for F35 Listening Session”¹

2. Vertical and horizontal groundwater and vapor contamination at WANG never completely assessed

3. Comprehensive assessment of effects of WANG stormwater runoff on Starkweather Creek

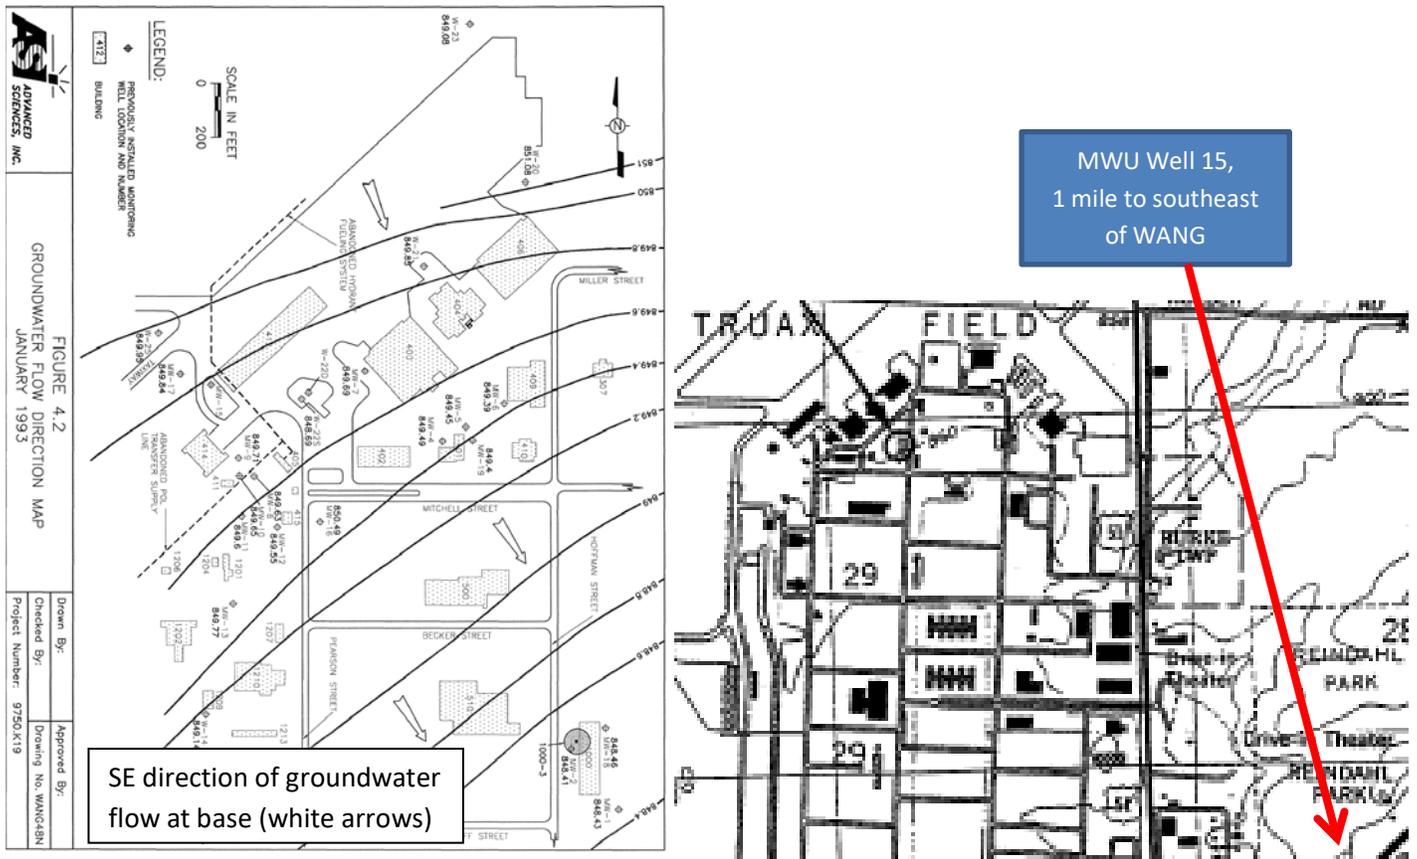
These consultants apparently overlooked the fact that there was (and still is) a Madison Water Utility public water supply well (Well 15) just one mile southeast of the site in Reindahl Park—in the direction of groundwater flow from the site. Well 15 is already contaminated with PCE, and several years ago a filter was installed there. See below maps from previous ANG site reports:

Several WANG consultant reports stated (incorrectly) that the nearest groundwater use was at Oscar Mayer. The 1998 Remedial Action Plan for Site 4, said “the direction of groundwater flow is toward the southeast” but “there are no known downgradient users of groundwater” because “the nearest potable supply wells are high-capacity wells located at the Oscar Mayer processing plant, approximately 1.5 miles southwest of the site.” (1998 RAP, p. 54-55)

In a recent Water Utility-funded investigation of the potential sources of PCE to Well 15, the WANG site was not considered (presumably because it was deemed to be outside of the zone of contribution?). Whether or not it is a source of the existing PCE contamination at Well 15, it would be prudent to have more information about the vertical and horizontal extents of any/all VOC plumes at WANG to know if this contamination could reach the well in the future.

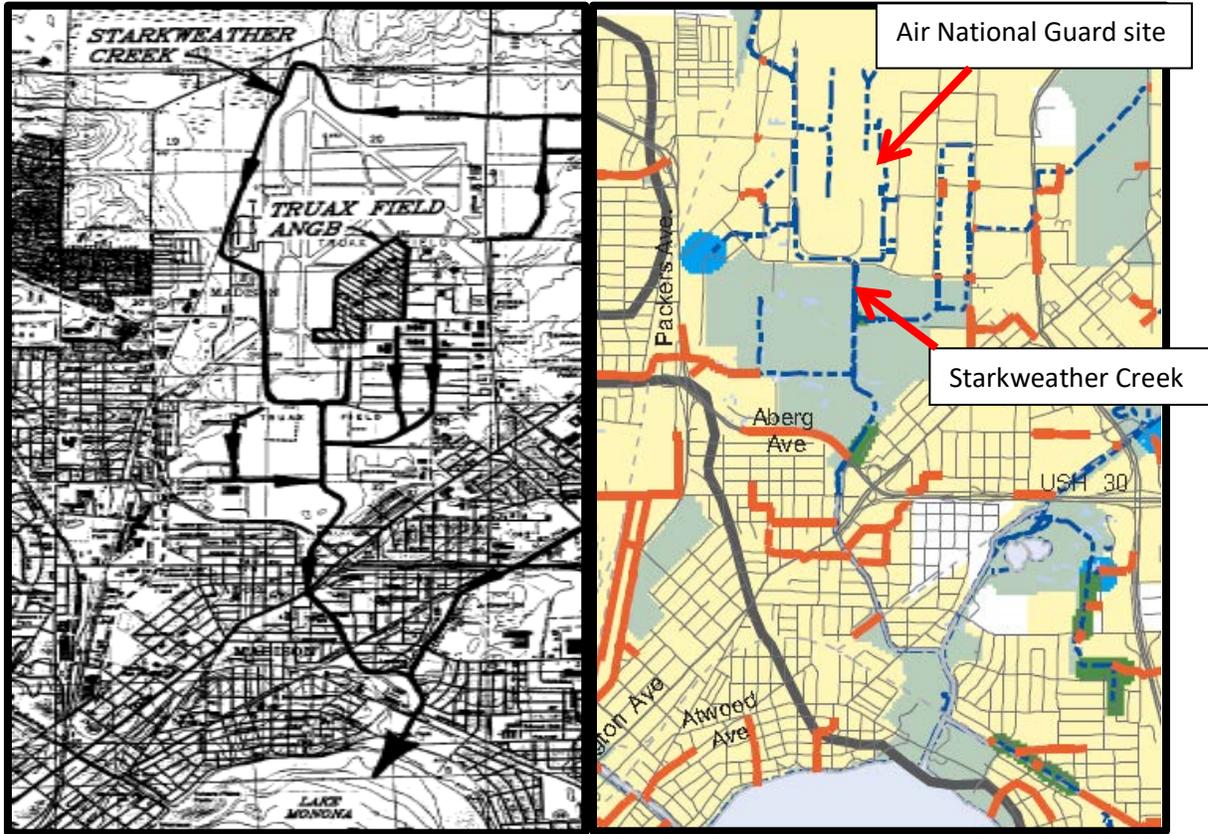
Starkweather Creek, a highly impaired 303(d) listed waterway, surrounds the Air National Guard site on three sides. All stormwater runoff from the site discharges to the creek, which then flows to Lake Monona (also highly impaired) about 2.5 miles south. The airport and ANG base were built on drained wetlands, and many ditches and culverts were built to drain the base’s stormwater runoff to the west branch of the creek to prevent flooding. Air National Guard investigative reports explicitly state this and include maps showing it—see map on the left:

Left: Map from 1988 Air National Guard report **Right:** 2005 City of Madison drainage system

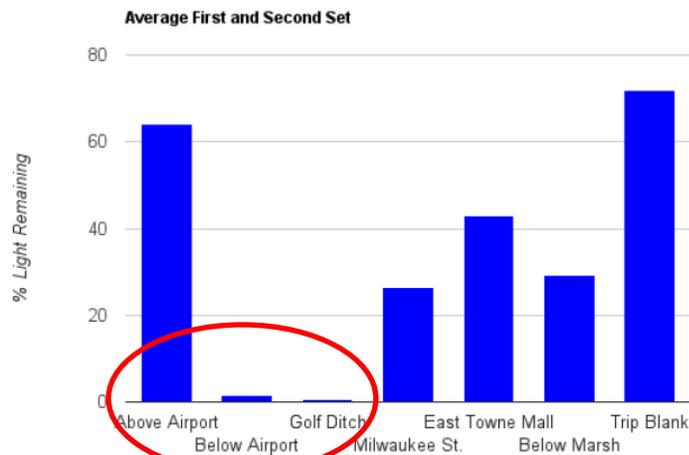
Figure 10: Averaged 2005 Results

Not surprisingly, sparse data available from Starkweather Creek indicate that stormwater runoff from the airport/WANG site has significantly and negatively affected it. Below is a summary of data from a “Microtox” test done on Starkweather Creek water in a 2005 University of Wisconsin Water Resources Management Study:

The blue bars, referring to the % “light remaining,” reflect the toxicity of the water—the more light remaining (the higher the blue bar), the less toxic the water. Based on this study, something is entering the stormwater at the Airport/Air National Guard sites that is increasing the toxicity of the water. Water quality was the worst in the area

further south of the airport near the “golf ditch”; this ditch drains the former city sewage disposal site/landfill area and Truax landfill,¹² which took hazardous wastes from the Truax DoD military operations.¹³

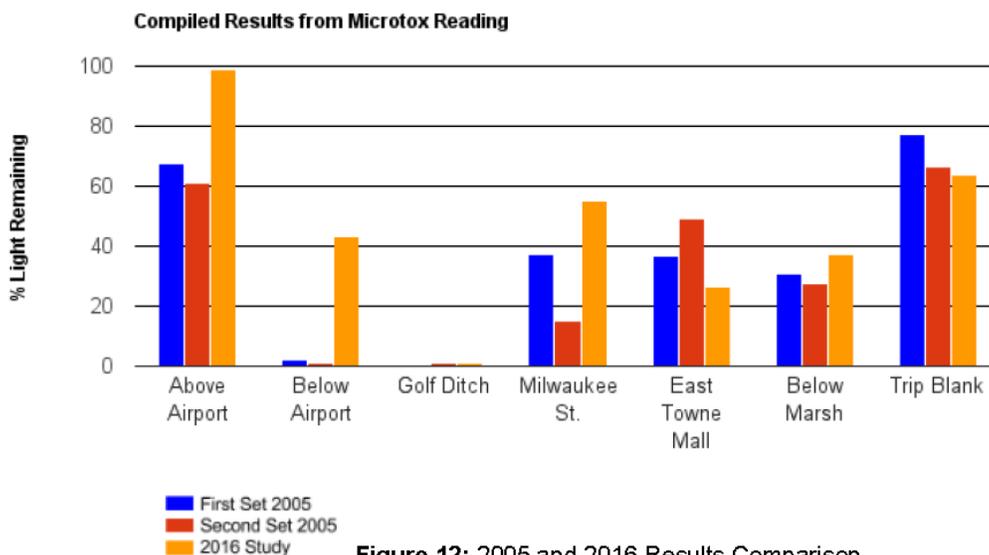
In 2016 sampling done by a local consulting firm (Freshwater Engineering), which replicated the 2005 study), the water quality at the site just below the airport was improved (but so was the upstream sample), but further south at the golf ditch site, the water quality was as bad as it was in 2005:
