Rain Garden – Interim Investigation Report and Proposed Excavation Work Plan

November 2017

*Prepared For
Madison-Kipp Corporation
Madison, Wisconsin*

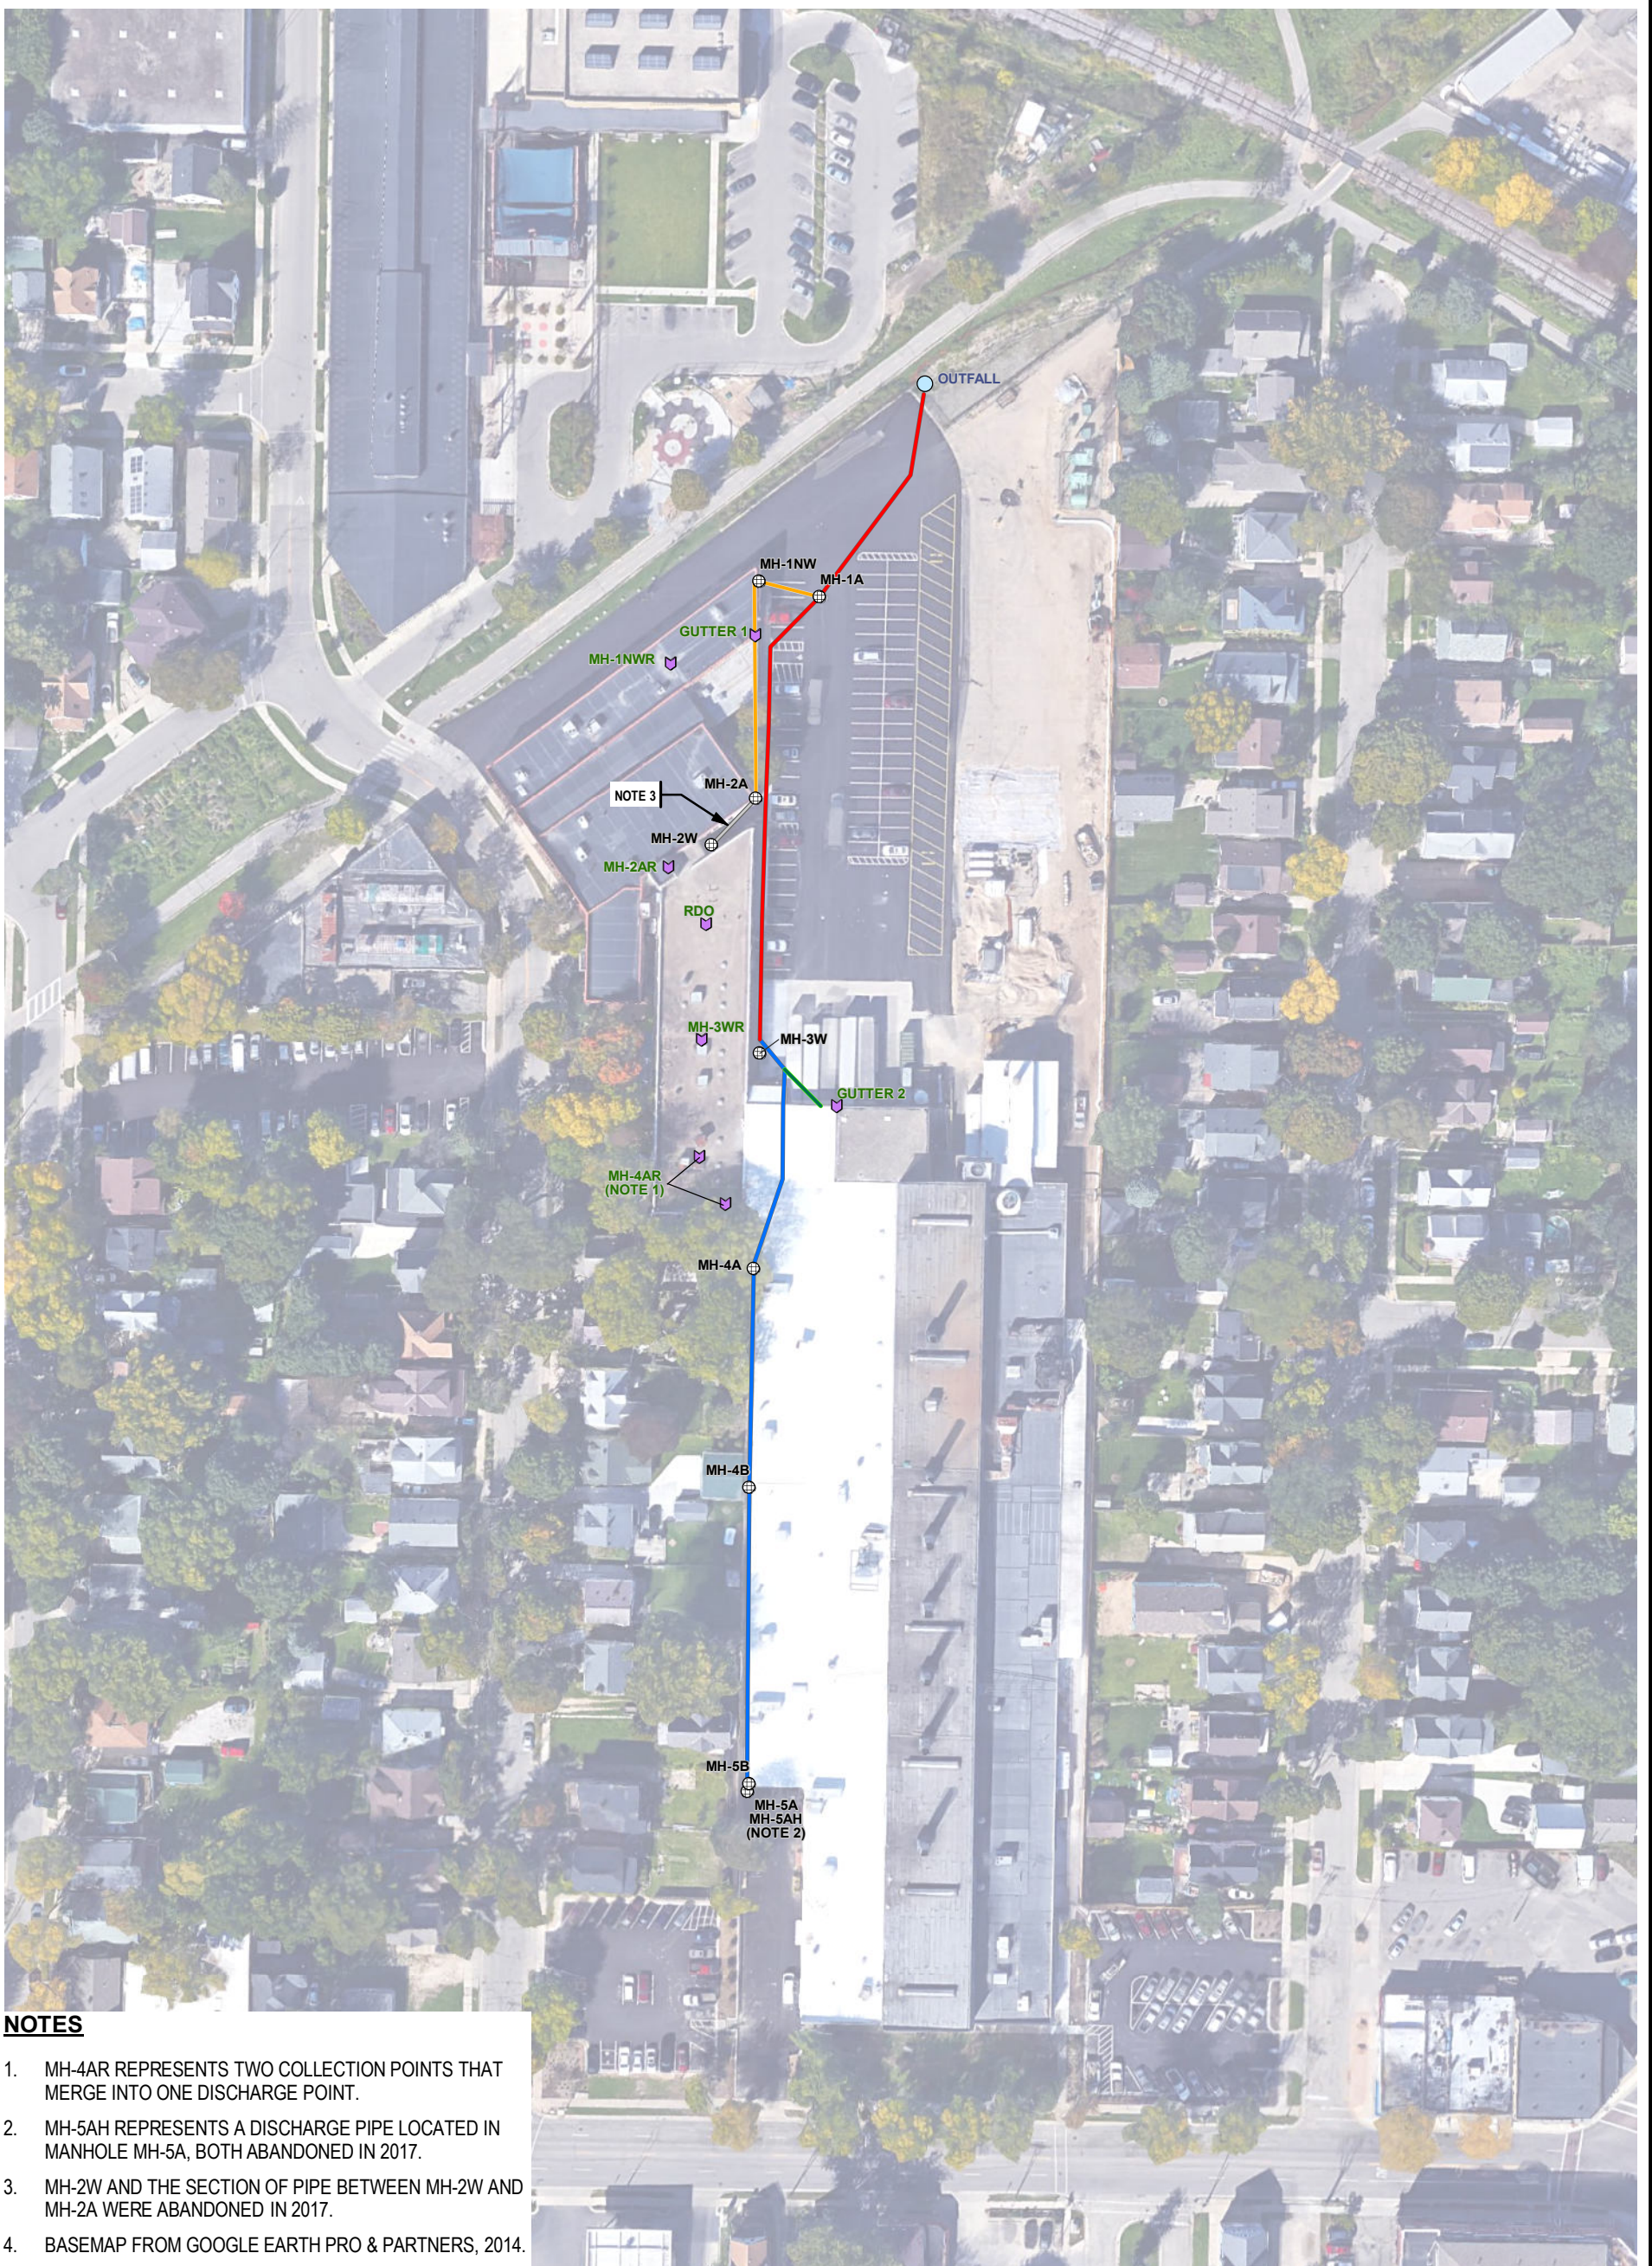
FIGURE 1

Figure 1	Site Map with Storm Sewer Infrastructure
----------	--

1. MH-4AR REPRESENTS TWO COLLECTION POINTS THAT MERGE INTO ONE DISCHARGE POINT.
2. MH-5AH REPRESENTS A DISCHARGE PIPE LOCATED IN MANHOLE MH-5A, BOTH ABANDONED IN 2017.
3. MH-2W AND THE SECTION OF PIPE BETWEEN MH-2W AND MH-2A WERE ABANDONED IN 2017.
4. BASEMAP FROM GOOGLE EARTH PRO & PARTNERS, 2014.
