233-269 Waubesa Street Properties

**Kipp's Atwood Plant
(facing Atwood Avenue)**

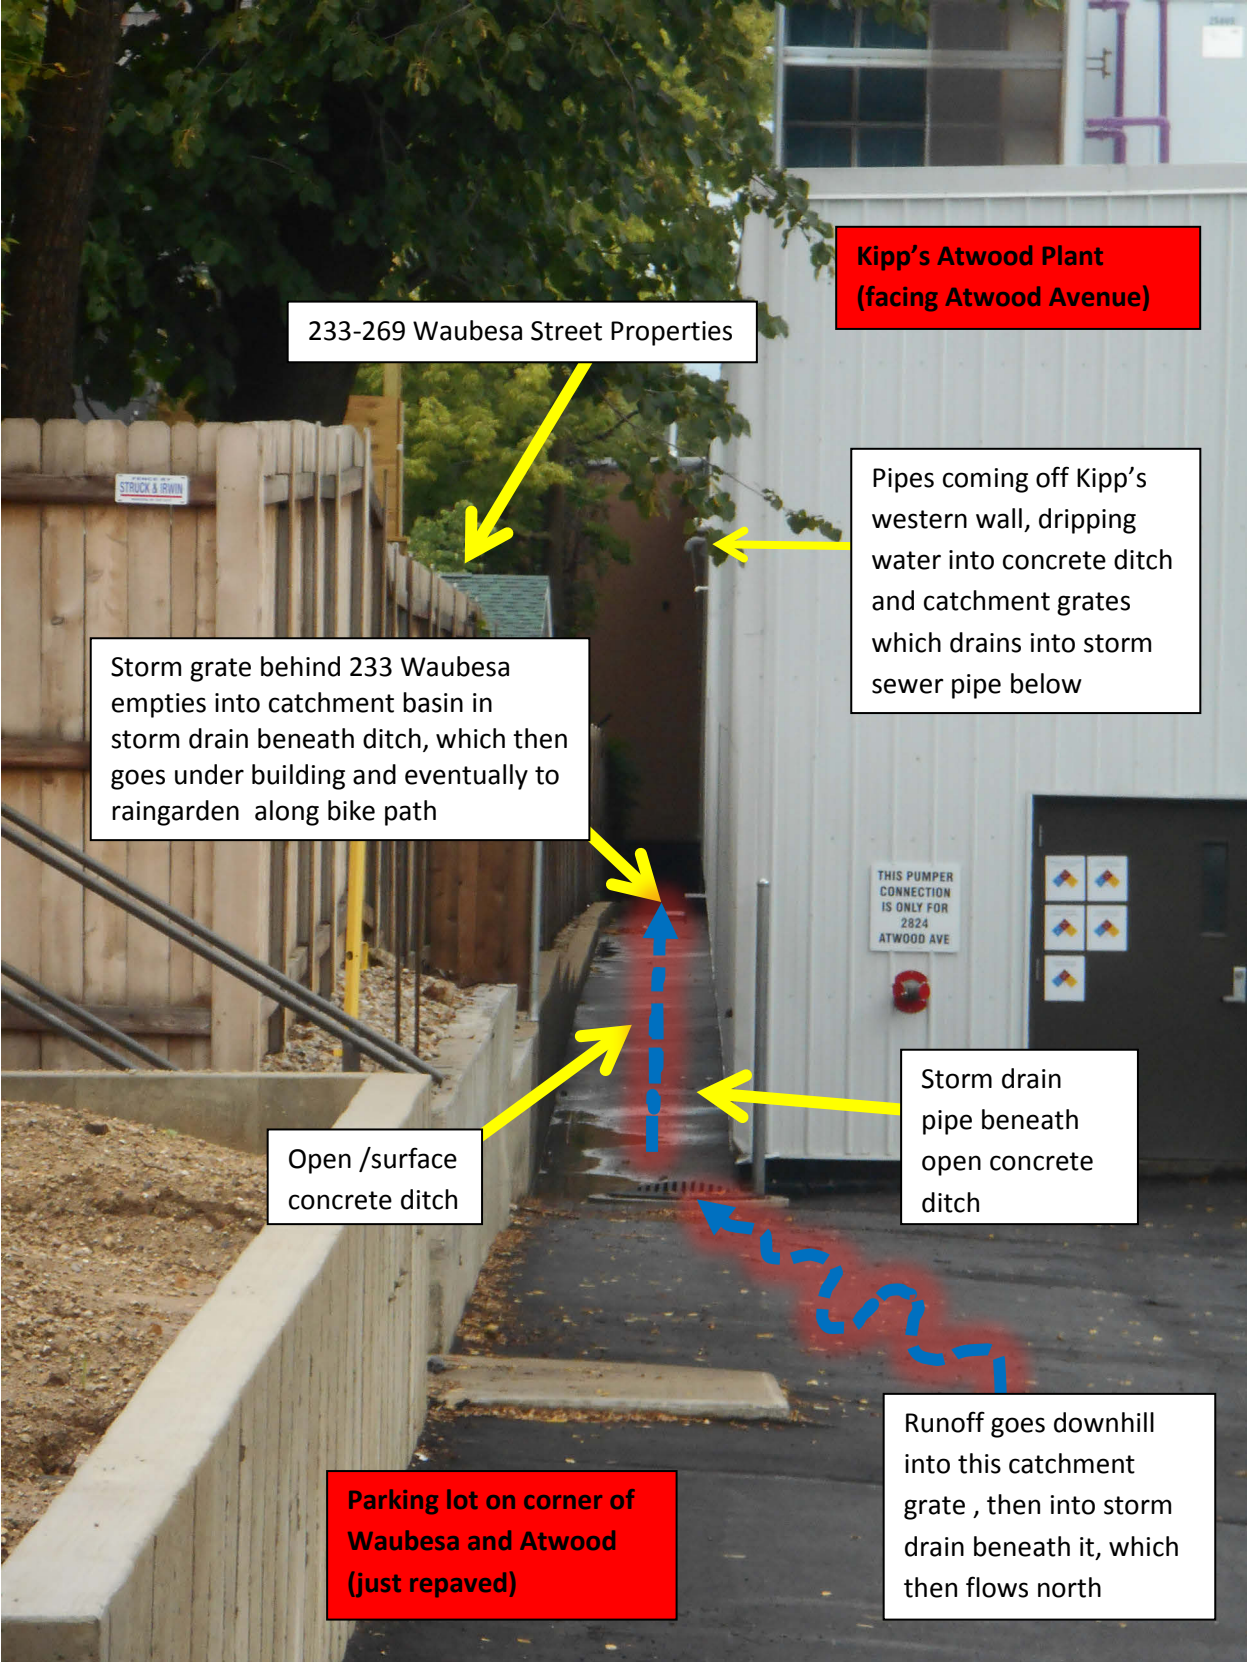
Pipes coming off Kipp's western wall, dripping water into concrete ditch and catchment grates which drains into storm sewer pipe below

Storm grate behind 233 Waubesa empties into catchment basin in storm drain beneath ditch, which then goes under building and eventually to raingarden along bike path

Open /surface concrete ditch

Storm drain pipe beneath open concrete ditch

THIS PUMPER CONNECTION IS ONLY FOR 2824 ATWOOD AVE

Parking lot on corner of Waubesa and Atwood (just repaved)

Runoff goes downhill into this catchment grate , then into storm drain beneath it, which then flows north
