From: [Punt, Colin](#)
To: [Plan Commission Comments](#)
Subject: FW: Oscar Mayer Health Assessment - Final
Date: Wednesday, December 7, 2022 10:14:28 AM
Attachments: [image001.png](#)
[image002.png](#)
[image003.png](#)
[image004.png](#)
[image005.png](#)

Summary	3
Acronyms.....	5
Public Health Assessment Process.....	6
Identifying Exposure Pathways.....	6
Contaminants of Concern (COC).....	6
Overview of Oscar Mayer (OM) and Hartmeyer Sites	8
Closed (2021) Site Investigation: Former Filling Station (East) Site (BRRTS# 02-13-580722).....	9
Soil Exposure Pathway	10
Groundwater Exposure Pathway.....	10
Continuing obligations.....	11
Limitations	12
Conclusions & Recommendations.....	12
1,2-DCA Above Ground Storage Tank Site (Open Site, BRRTS# 02-13-580721) & Closed Site #3 (BRRTS# 03-13-114831)	13
1,2-DCA Site Exposure Pathway.....	14
Soil Exposure Pathway	15
Groundwater Exposure Pathway.....	16
Closed site #3 Soil and Groundwater Exposure Pathway.....	16
1,2-DCA Tank Site Remedial Actions.....	16
Closed Site #3 Continuing obligations.....	17
1,2-DCA site and Closed Site #3 Limitations.....	18
Open Site: Former Spice Room (Building 43, BRRTS# 02-13-580723)	19
Vapor Intrusion Exposure

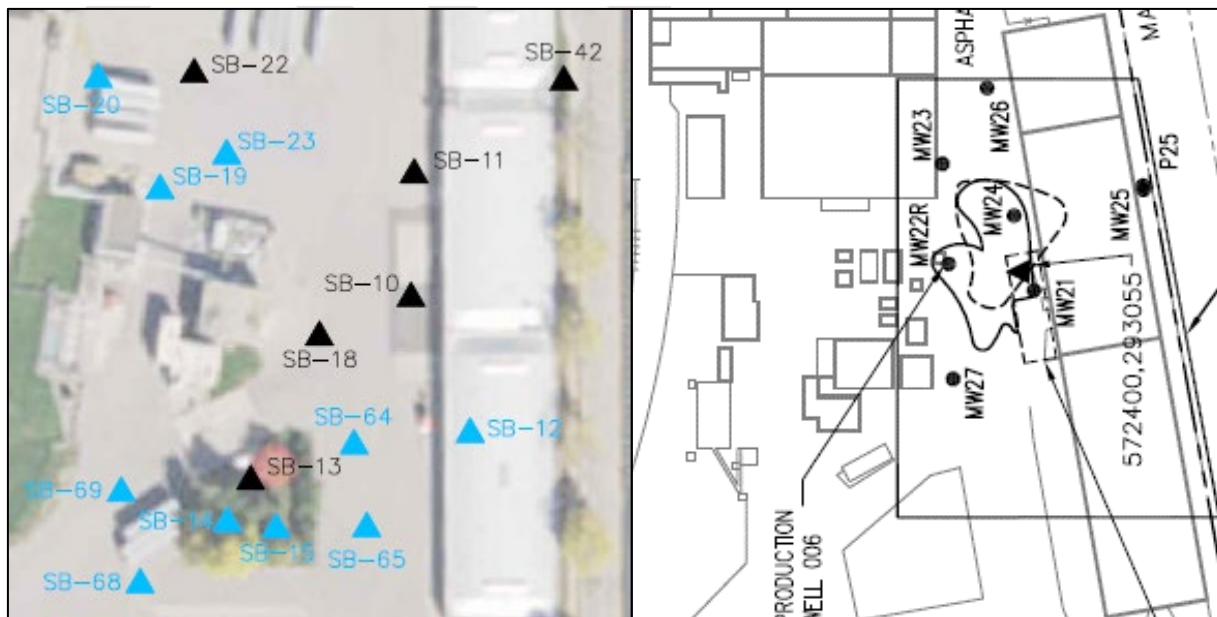
Figure 4. Closed Site #3 with 2017 data near site (left) and 1996 (right) extent of contamination.

soil and groundwater analytical results were taken in 1996 and 1997 from the excavation to determine soil and groundwater contamination at the site. The cap is required to be maintained and inspected annually to determine its integrity. Sampling was also performed on this site as part of the 2017 Oscar Mayer investigation. Additional soil samples and groundwater samples were taken throughout Oscar Mayer property in 2017. The samples were also taken on the former 1,2-DCA tank site and from the area near Closed Site #3 (Figure 4 and Figure 5). Soil samples in the top 5 feet of soil (SB-11, SB-12, SB-18, SB-19, SB-23, SB-42) where the soil is most accessible, and groundwater samples (SB-10, SB-12, SB-18, SB-19, SB-23, SB-42, SB-64) were also taken near the former UST site behind the Bodgery.

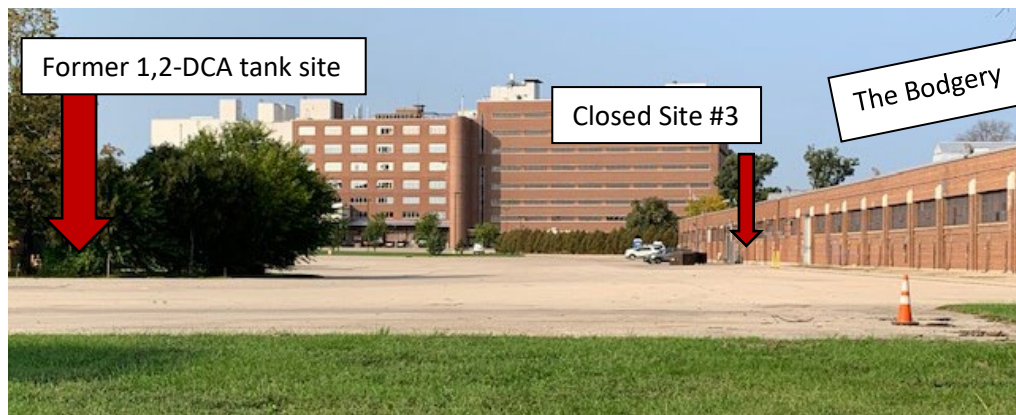
Figure 6. The former 1,2-DCA Tank location behind the Bodgery, which is a community building used as a makerspace for artists and community members.

Bodgery, there is a “garage door” type entrance to the building and a side door. Both appeared to not be in use (Figure 6). The fencing right outside this area does have a “No Trespassing” sign (Figure 7). A building at the back of the lot did appear to be in use with cars parked in the parking lot but it appeared to be for the building labeled “Nine-Ten” which is being leased out by a third party company. Upon further

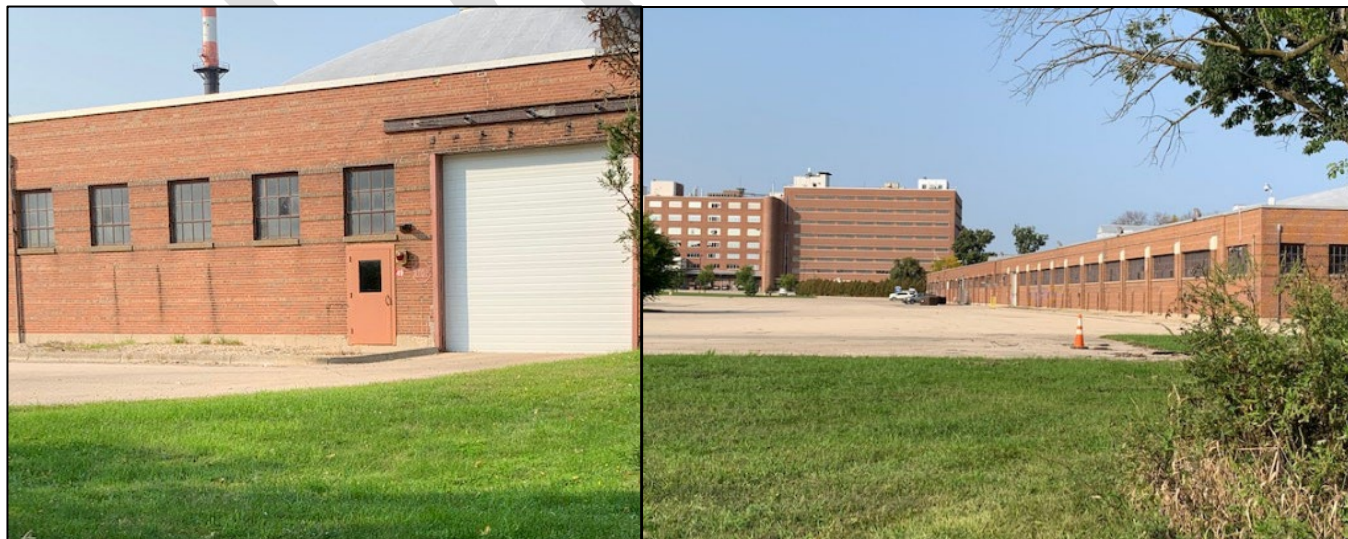
Figure 8. The south side of the Bodgery building adjacent to the former 1,2-DCA tank site

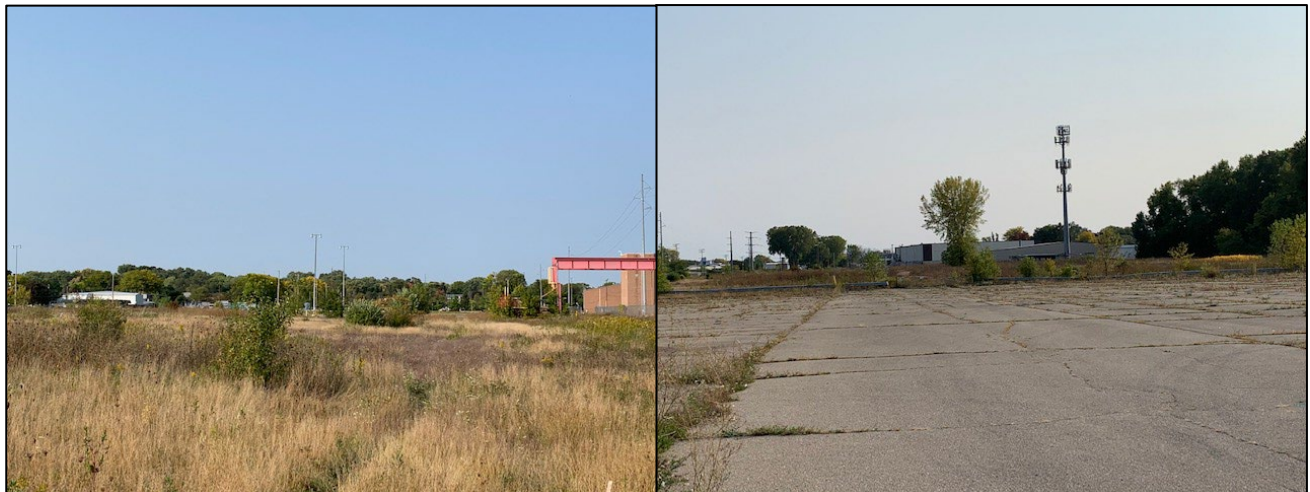
Figure 10. Hartmeyer site looking South to North (left photo) and looking north to South (right photo).

Currently, this site is easily accessible to the general public, is not enclosed by a fence, and there is no signage on the property. It also sits adjacent to businesses with parking lots. The northwestern portion of the site is partially capped with pavement. The site is also covered with dense vegetation (Figure 10 and 11) and there are railroad tracks to the east of the site that would limit access in that direction. As long as these features ensure sub-surface soils remain inaccessible, ingestion or dermal exposure to contaminated soil is unlikely and the exposure pathway for contaminated soil at the site is considered to be incomplete

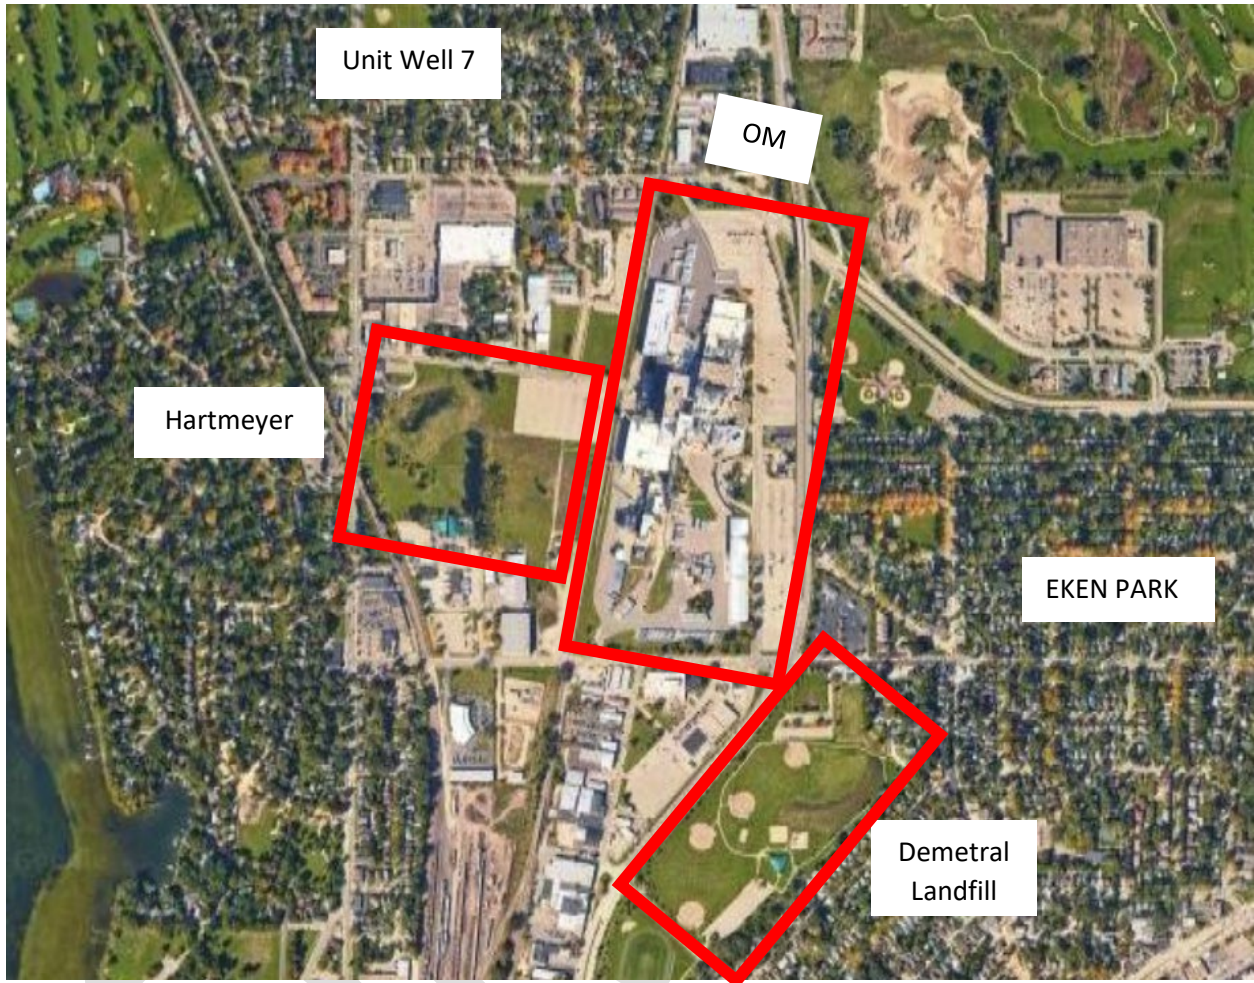
Figure 2. Overview of Central Oscar Mayer and Hartmeyer open sites and neighborhood.

Immediately south of the West Property portion of the Oscar Mayer site is the Hartmeyer site (Appendix A, Figure 2) which was previously leased to Kraft by the Hartmeyer family. The Hartmeyer site has been previously sampled and was considered as part of our assessment. The Hartmeyer site also has an open BRRTS investigation where 50 additional soil borings were analyzed for contaminants in 2020 for arsenic and benzo(a)pyrene. In 2019, 19 soil boring samples were analyzed. This contaminant data was used for evaluation of soil contamination (Appendix A, Figure 7).

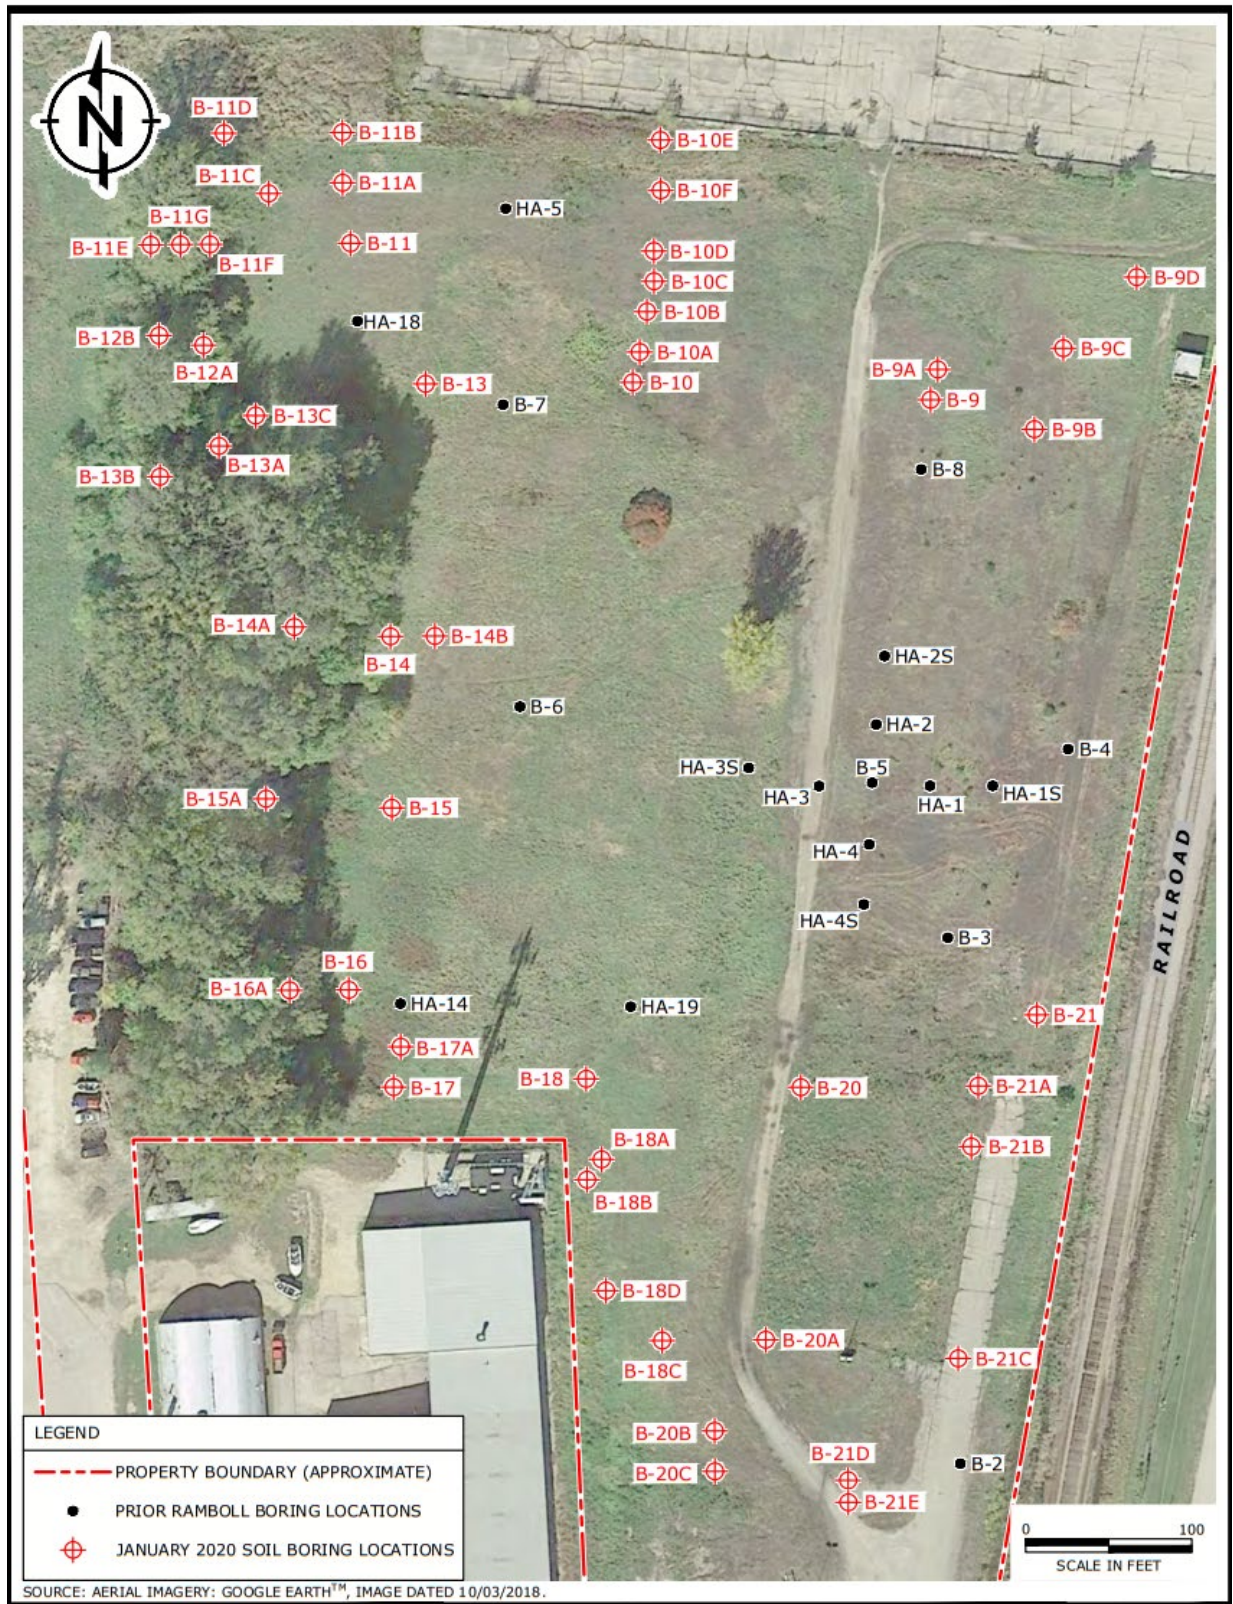
Figure 5. Soil Boring Location Map on the Oscar Mayer Property, 2020

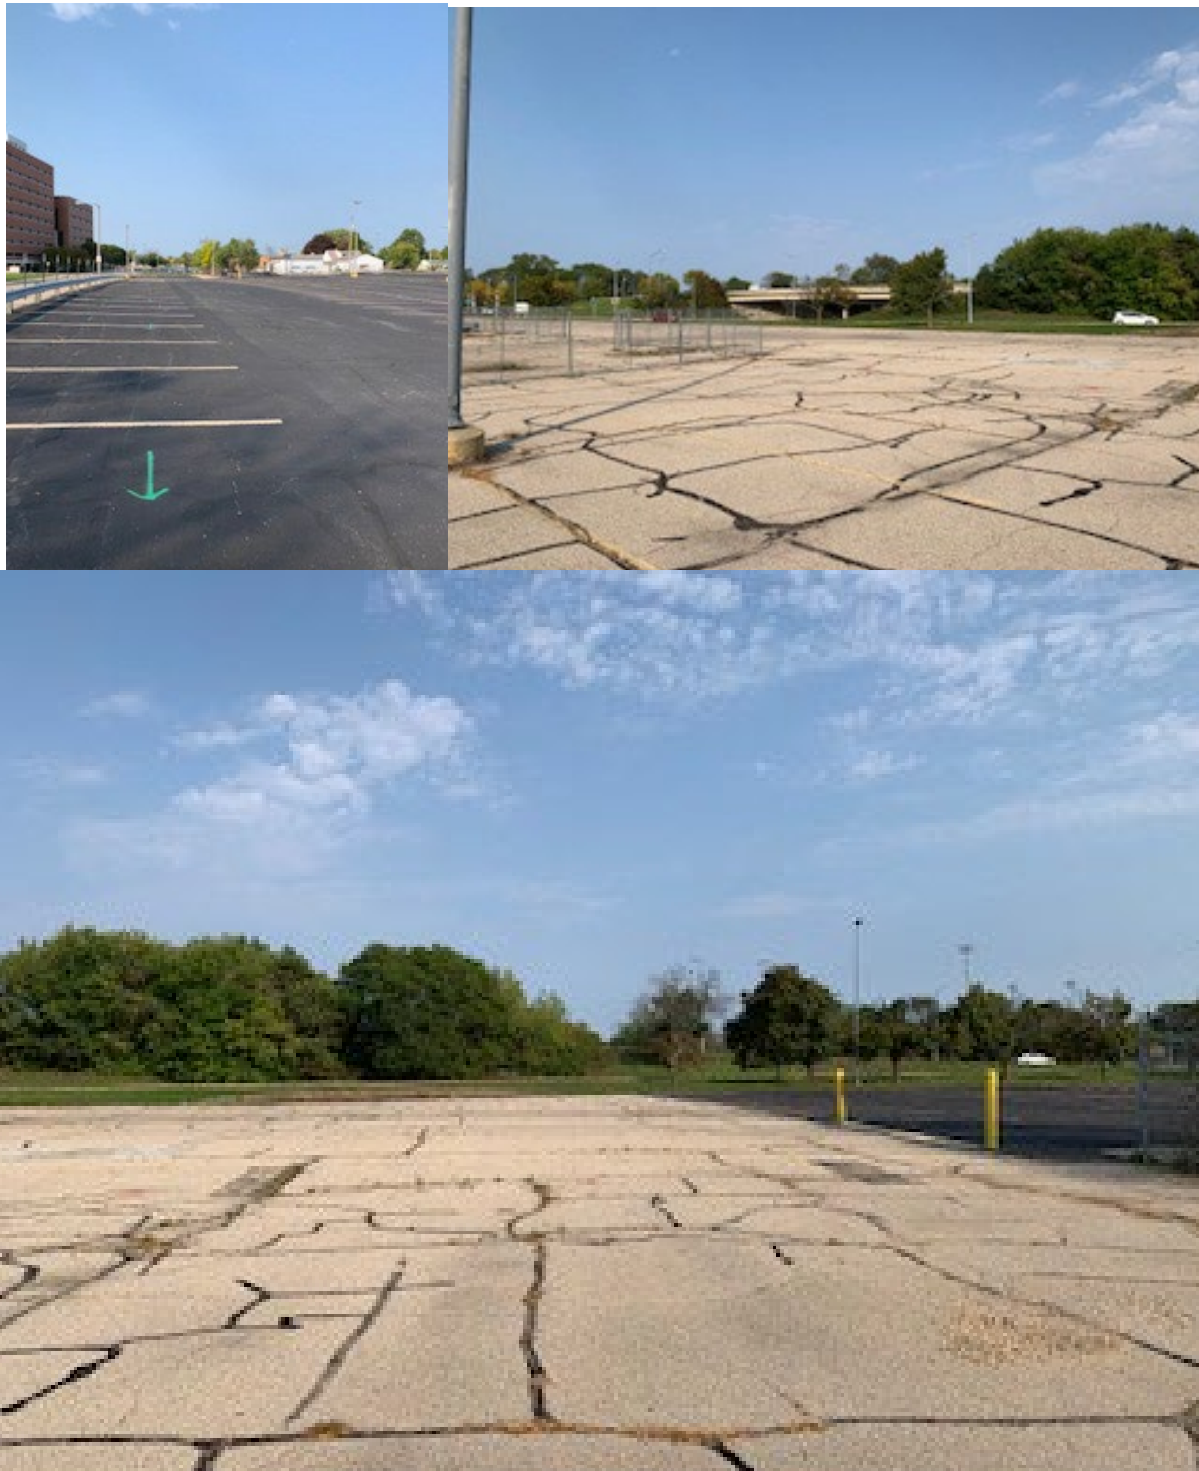
Figure 6. Former Filling Station Site covered by Parking lot
